# Doña Ana County

AMERICANS WITH DISABILITIES ACT  
SELF-EVALUATION  
AND  
TRANSITION PLAN  
DECEMBER 2017

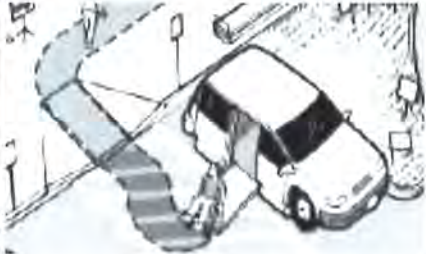
<b>Estimated Cost:</b>	<b>\$3,999.10</b>	
<b>Priority Level:</b>	<b>Low</b>	
<b>Barrier Description/Proposed Solution:</b> The existing access aisle slope is 3:48 in all directions. ADA Standards require that the slope of the accessible parking space and access aisle be no steeper than 1:48 in all directions. It is recommended that the surface be regraded. An estimate has been developed for the demolition of the existing paving and curbing and its reconstruction.

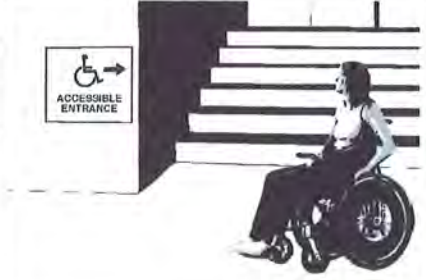
<b>Estimated Cost:</b>	<b>\$83.16</b>	
<b>Priority Level:</b>	<b>Low</b>	
<b>Barrier Description/Proposed Solution:</b> The existing entrance requires a directional sign that indicates the location of the nearest accessible entrance. An estimate has been developed for the installation of a new tactile text with Braille sign.

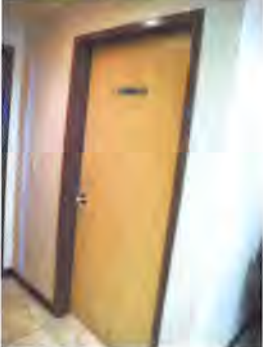
<b>Estimated Cost:</b>	<b>\$220.64</b>	
<b>Priority Level:</b>	<b>Medium</b>	
<b>Barrier Description/Proposed Solution:</b> This facility has 3 restrooms; 1 which is accessible. A directional sign indicating the location of the accessible restroom should be installed at the inaccessible restrooms. 3 tactile text with Braille signs require installation. An estimate has been developed for the work item noted.

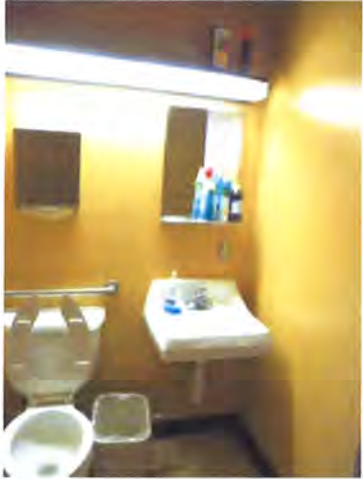
<b>Estimated Cost:</b>	<b>\$799.56</b>	
<b>Priority Level:</b>	<b>Low</b>	
<b>Barrier Description/Proposed Solution:</b> Several work items in the existing accessible restroom are required for compliance with the referenced sections. The existing mirror and towel dispenser require relocation to the required mounting height (603.3). The existing coat hook requires adjustment to proper mounting height of 15"-48" (603.4). The lavatory pipes require insulation to protect against contact (606.5). The existing accessible restroom lacks grab bars and requires the installation on a 36" rear grab bar and a 42" sidewall grab bar (604.5.1, 604.5.2). An estimate has been developed for the work items listed.

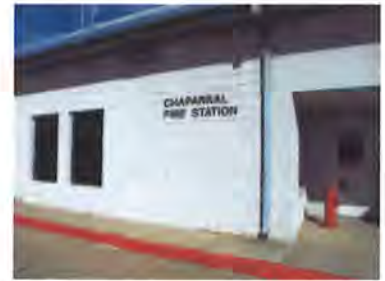
<b>ADA Standard Reference:</b>	<b>216.6</b>
<b>Estimated Cost:</b>	<b>\$ 189.74</b>
<b>Priority Level:</b>	<b>Low</b>
<b>Barrier Description/Proposed Solution:</b> Entrances that are inaccessible do not have directional signs indicating the location of the nearest accessible entrance, and accessible entrances do not have signs with the International Symbol of Accessibility. Install 2 new signs for directional and identification purposes.

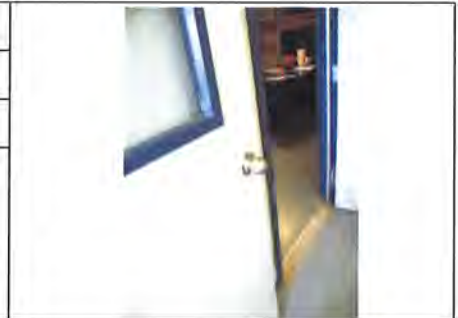
<b>ADA Standard Reference:</b>	<b>404.2.7</b>
<b>Estimated Cost:</b>	<b>\$2,798.25</b>
<b>Priority Level:</b>	<b>Medium</b>
<b>Barrier Description/Proposed Solution:</b> The hardware on the existing interior doors is comprised of knob type lock sets. It is recommended that the lock sets be replaced with lever type sets to comply with the requirements of this section. An estimate has been developed for the item noted.

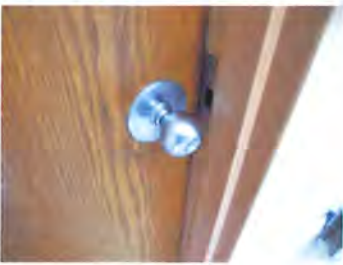
<b>Estimated Cost:</b>	\$559.98	
<b>Priority Level:</b>	Medium	
<b>Barrier Description/Proposed Solution:</b> The hardware on the existing restroom doors is comprised of knob type lockets. An estimate has been developed to remove and replace the knob type lockets with lever type locksets.

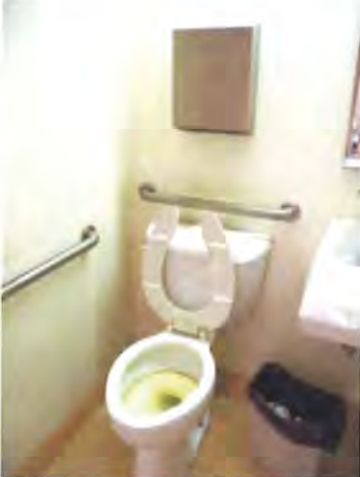
<b>Estimated Cost:</b>	\$863.13	
<b>Priority Level:</b>	Low	
<b>Barrier Description/Proposed Solution:</b> Several work items in the existing accessible restroom are required for compliance with the referenced sections. The existing mirror requires relocation to the required mounting height (603.3). An additional coat hook requires installation (603.4). The lavatory pipes require insulation to protect against contact (606.5). The paper towel dispenser requires vertical adjustment (308.2). The existing sidewall and rear wall grab bars need to be replaced with an appropriate 42" and 36" bar (604.5.1, 604.5.2). The flush control on the water closet requires relocation to the open side of the unit (604.6).

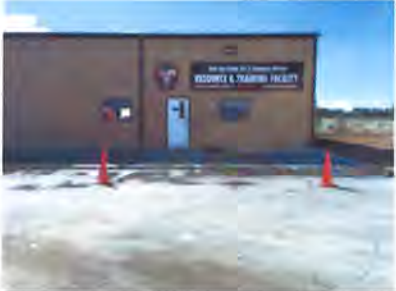
<b>Estimated Cost:</b>	<b>\$2,485.75</b>	
<b>Priority Level:</b>	<b>Medium</b>	
<b>Barrier Description/Proposed Solution:</b> The existing accessible parking requires reconfiguration to comply with the requirements of the referenced sections. Work items to include: restriping for 2 “van accessible” spaces that align with the entrance and installation of 2 new ADA parking signs. Access aisles should be painted with blue paint and include text that indicates “NO PARKING”.

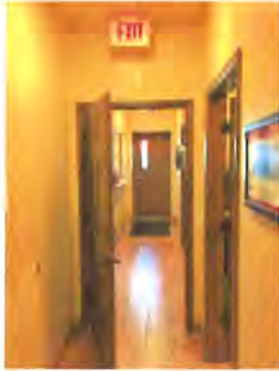
<b>Estimated Cost:</b>	<b>\$106.58</b>	
<b>Priority Level:</b>	<b>Medium</b>	
<b>Barrier Description/Proposed Solution:</b> The existing door in the hallway creates an obstruction. ADA Standards require that there is a front approach to the pull side of the door and that there is at least 18” of maneuvering clearance beyond the latch, with at least 60” of clear depth. An estimate has been developed for the removal of the door in the hallway to provide for a clear path.

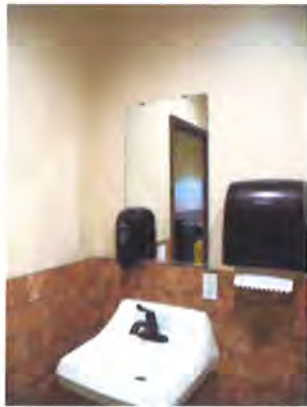
<b>Estimated Cost:</b>	\$324.69	
<b>Priority Level:</b>	Low	
<b>Barrier Description/Proposed Solution:</b> Several work items in the existing accessible restroom are required for compliance with the referenced sections. The existing mirror requires relocation to the required mounting height (603.3). The existing sidewall grab bar needs to be replaced with an appropriate 42" bar (604.5.1). The rear wall grab bar requires horizontal adjustment (604.5.2). An estimate has been developed for the work items listed.

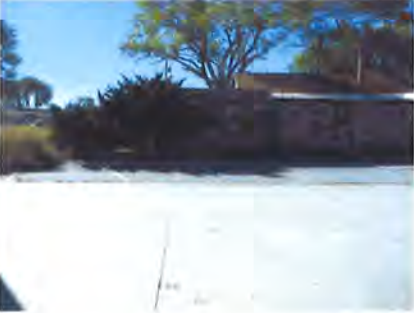
<b>Estimated Cost:</b>	<b>\$2,685.01</b>	
<b>Priority Level:</b>	<b>Medium</b>	
<b>Barrier Description/Proposed Solution:</b> The existing accessible parking requires reconfiguration to comply with requirements of the referenced sections. The parking area has a drainage swale that goes through the access aisle creating a slope greater than 1:48. The access aisle does not adjoin an accessible route. There is not a sign with the International Symbol of Accessibility and "van accessible" denotation installed. The accessible stall is not located at the closest route to the entrance. Access aisles should be painted with blue paint and include text that indicates "NO PARKING". An estimate has been developed to reconfigure the parking to comply with the requirements of the referenced sections.

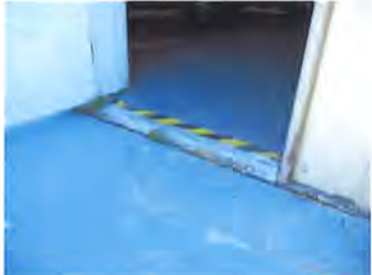
<b>Estimated Cost:</b>	<b>\$248.65</b>	
<b>Priority Level:</b>	<b>Low</b>	
<b>Barrier Description/Proposed Solution:</b> At the existing entry door the threshold has a 2" step. An estimate has been developed for the installation of a threshold ramp.

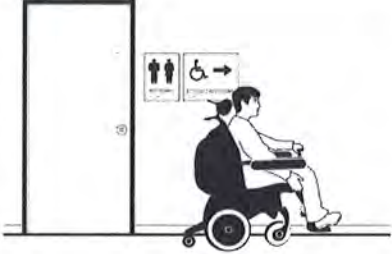
<b>Estimated Cost:</b>	<b>\$211.77</b>	
<b>Priority Level:</b>	<b>Low</b>	
<b>Barrier Description/Proposed Solution:</b> This facility has 2 restrooms; 1 which is accessible. A sign indicating accessibility is required to comply with the referenced sections. An estimate has been developed for the installation of a new tactile text with Braille sign.

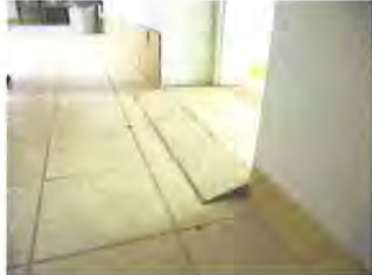
<b>Estimated Cost:</b>	<b>\$218.56</b>	
<b>Priority Level:</b>	<b>Low</b>	
<b>Barrier Description/Proposed Solution:</b> Each of the restroom doors has a built-up threshold that is greater than 1.5". This creates a tripping hazard and blocks wheelchair access. An estimate has been developed to remove the built-up threshold and install new tile to match.

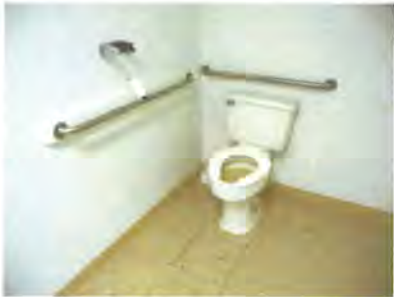
<b>Estimated Cost:</b>	\$239.09	
<b>Priority Level:</b>	Low	
<b>Barrier Description/Proposed Solution:</b> The distance of the water closet in the noncompliant restroom is greater than the maximum 18" to the centerline. Making the other available restroom accessible would not require the relocation of this unit; however, an estimate for the relocation of the water closet has been developed.

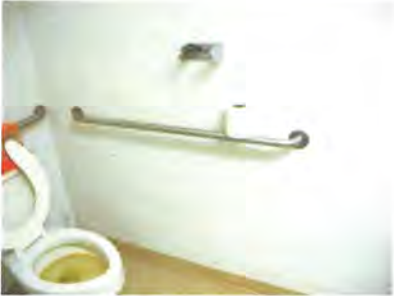
<b>Estimated Cost:</b>	\$446.84	
<b>Priority Level:</b>	Medium	
<b>Barrier Description/Proposed Solution:</b> The grab bars in both restrooms require adjustments to comply with the requirements of this section.

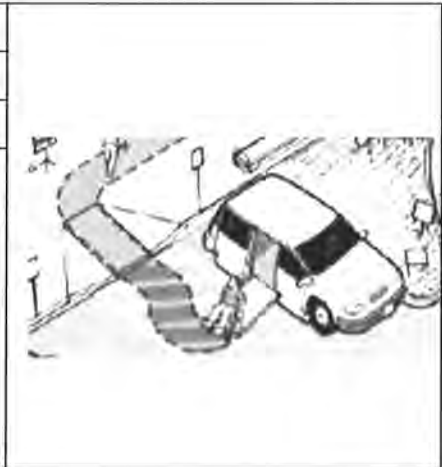
<b>ADA Standard Reference:</b>	502.6
<b>Estimated Cost:</b>	\$313.80
<b>Priority Level:</b>	Low
<b>Barrier Description/Proposed Solution:</b> The existing ADA accessible parking sign is mounted below the allowable mounting height. An estimate has been developed to replace the sign with a new sign that is mounted at the correct height and designated as a "van accessible" space.

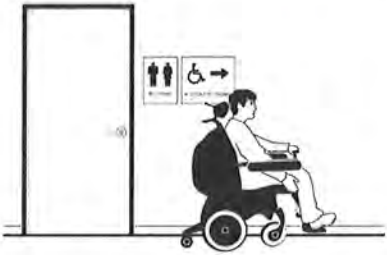
<b>Estimated Cost:</b>	<b>\$211.77</b>	
<b>Priority Level:</b>	<b>Low</b>	
<b>Barrier Description/Proposed Solution:</b> This facility has 2 restrooms; 1 which is accessible and marked as the "Women's" restroom. Both restrooms require new ADA compliant signs. An estimate has been developed for the installation of new tactile text with Braille signs.

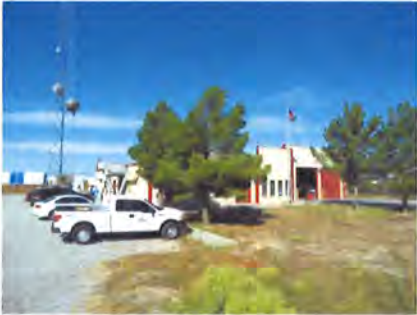
<b>Estimated Cost:</b>	\$3,819.00	
<b>Priority Level:</b>	High	
<b>Barrier Description/Proposed Solution:</b> The existing gravel parking lot requires several work items to be in compliance. An estimate has been developed for the following items: construction of a new concrete pad, installation of 2 new accessible spaces and access aisle, pavement markings, parking bumpers, and a new handicap sign. Access aisles should be painted with blue paint and include text that indicates "NO PARKING".

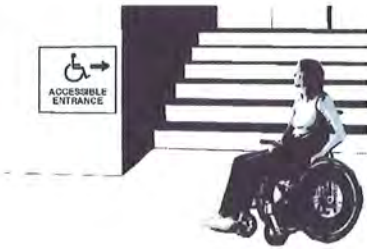
<b>Estimated Cost:</b>	\$189.74	
<b>Priority Level:</b>	Low	
<b>Barrier Description/Proposed Solution:</b> Entrances that are inaccessible do not have directional signs indicating the location of the nearest accessible entrance, and accessible entrances do not have signs with the International Symbol of Accessibility. An estimate has been developed for the installation of 2 new signs for directional and identification purposes.

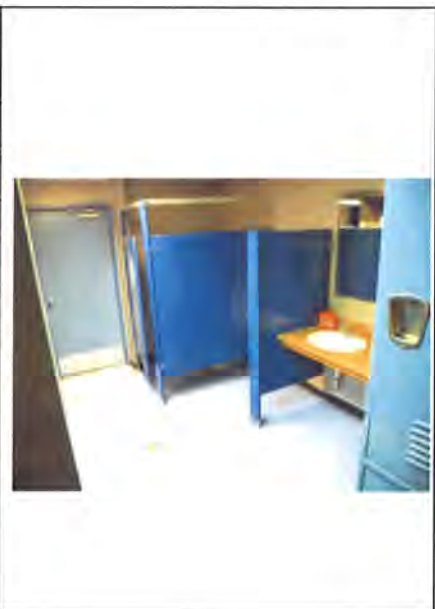
<b>ADA Standard Reference:</b>	<b>603.3, 603.4, 604.2, 604.4, 604.5.1, 604.5.2, 604.8.1.1, 604.8.1.2, 606.5, 608.2.2</b>
<b>Estimated Cost:</b>	<b>\$3,790.37</b>
<b>Priority Level:</b>	<b>Medium</b>
<b>Barrier Description/Proposed Solution:</b> Several work items in the existing Men's restroom are required for compliance with the referenced sections. The mirror is mounted above the maximum height of 40" AFF (603.3). The provided coat hook is mounted above the maximum height of 54" AFF (603.4). Lavatory pipes require insulation to protect against contact (606.5). The soap dispenser is mounted above the maximum height of 48" AFF (608.2.2). The distance of the water closet is further away from the side wall than the maximum 18" (604.2). The height of the water closet is below the minimum height of 17" (604.4). The grab bars provided do not comply with the ADA requirements (604.5.1, 604.5.2). The existing toilet compartment does not comply with the minimum clear space requirements (604.8.1.1, 604.8.1.2). An estimate has been developed for the work items listed.

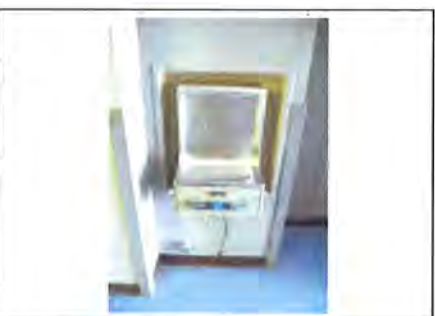
<b>ADA Standard Reference:</b>	<b>602.5</b>
<b>Estimated Cost:</b>	<b>\$3,284.71</b>
<b>Priority Level:</b>	<b>Low</b>
<b>Barrier Description/Proposed Solution:</b> The existing drinking fountain does not comply with the requirements of this section. An estimate has been developed for the removal and replacement of the existing fountain with a new compliant unit.

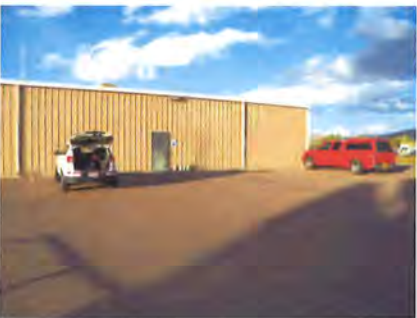
<b>Estimated Cost:</b>	\$4,559.44	
<b>Priority Level:</b>	Medium	
<b>Barrier Description/Proposed Solution:</b> The existing accessible parking space requires several work items for compliance with the referenced sections. The slope of the space exceeds 1:48, it is not designated as "van accessible" and the sign requires appropriate mounting. It is recommended that the existing asphalt be removed and a new concrete pad be installed that is in compliance with the referenced sections. New access aisles should be painted with blue paint and include text that indicates "NO PARKING". An estimate has been developed for the work items listed.

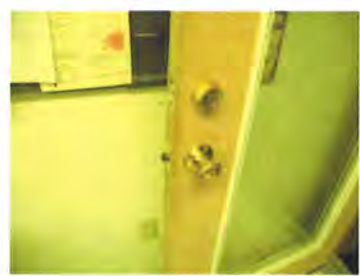
<b>Estimated Cost:</b>	\$1,306.62	
<b>Priority Level:</b>	Medium	
<b>Barrier Description/Proposed Solution:</b> The hardware on the existing interior doors is comprised of knob type locksets. It is recommended that the knob type locksets be replaced with lever type locksets to comply with the requirements of this section. An estimate has been developed for the item noted.

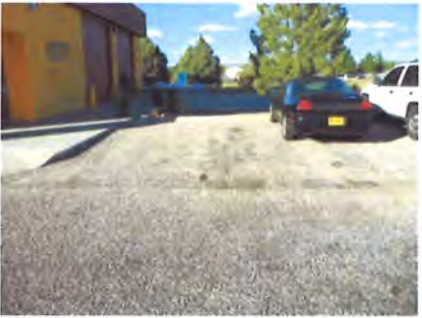
<b>ADA Standard Reference:</b>	<b>208.2.4, 502.2, 502.3, 502.6</b>

<b>Estimated Cost:</b>	<b>\$3,167.53</b>	
<b>Priority Level:</b>	<b>Medium</b>	
<b>Barrier Description/Proposed Solution:</b> The existing parking lot has 12 parking spaces; 1 which is ADA accessible. ADA Standards require that there be at least 1 "van accessible" space. The existing parking surface is chip and seal and does not provide a level surface. An estimate has been developed for the installation of a new 13'x22' concrete pad with appropriate pavement markings and ADA signs. Access aisles should be painted with blue paint and include text that indicates "NO PARKING".

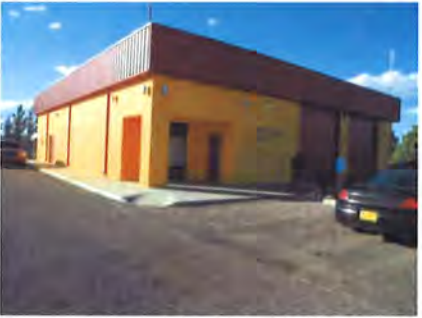
<b>Estimated Cost:</b>	<b>\$539.37</b>	
<b>Priority Level:</b>	<b>Medium</b>	
<b>Barrier Description/Proposed Solution:</b> The existing diagonal curb ramp is only accessible by entering traffic lanes. ADA Standards require that access aisles adjoin an accessible route. An estimate has been developed for the construction of a curb cut at the existing access aisles. This estimate includes demolition where the curb and access aisle meet, replacement of a new sidewalk access route, base course, and tactile warning tiles.

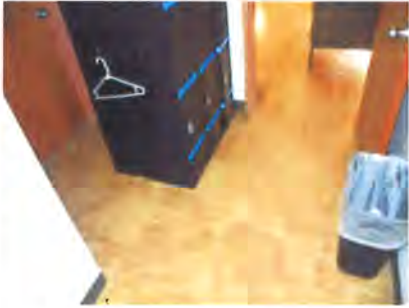
<b>ADA Standard Reference:</b>	<b>404.2.4</b>

<b>Estimated Cost:</b>	<b>\$254.31</b>	
<b>Priority Level:</b>	<b>Medium</b>	
<b>Barrier Description/Proposed Solution:</b> The existing lockers block the maneuvering clearances in the room. There is currently 53" of clear depth and 5" of maneuvering clearance. ADA Standards require that if there is a front approach to the pull side of the door, that there be at least 18" of maneuvering clearance beyond the latch side of the door, with an additional 60" of clear depth. An estimate has been developed to remove the lockers to create more space.

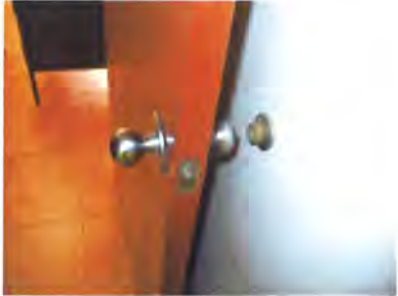
<b>ADA Standard Reference:</b>	<b>404.2.7</b>

<b>Estimated Cost:</b>	<b>\$539.37</b>	
<b>Priority Level:</b>	<b>Medium</b>	
<b>Barrier Description/Proposed Solution:</b> The existing restrooms are equipped with knob type locksets and require replacement with lever type locksets. An estimate has been developed for the installation of 3 new lever type locksets.

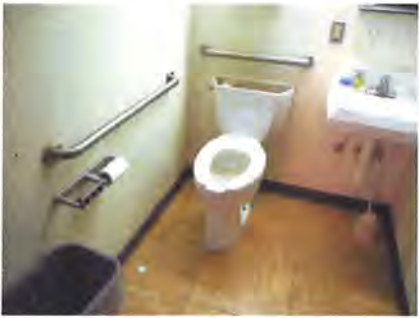
<b>Estimated Cost:</b>	\$819.03	
<b>Priority Level:</b>	Low	
<b>Barrier Description/Proposed Solution:</b> Several work items in the existing accessible restroom are required for compliance with the referenced sections. The existing mirror and towel dispenser require removal and replacement with a combined mirror and towel dispenser (603.3) The existing coat hook requires relocation to the required mounting height (603.4). The lavatories piping requires insulation to protect against contact (606.5). The faucet requires removal and replacement (606.4). Both sidewall and rear wall grab bars require installation (605.1, 605.2). The flush control on the water closet requires relocation to the open side of the unit (604.6). An estimate has been developed for the work items listed.

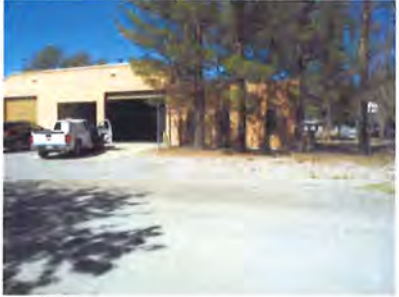
<b>ADA Standard Reference:</b>	208.2, 502

<b>Estimated Cost:</b>	\$2,536.73	
<b>Priority Level:</b>	High	
<b>Barrier Description/Proposed Solution:</b> This facility does not have any identified parking spaces provided, nor does it designate any accessible spaces. It is recommended that a new concrete pad be installed to provide 2 new accessible parking spaces with an access aisle. Access aisles should be painted with blue paint and include text that indicates "NO PARKING".

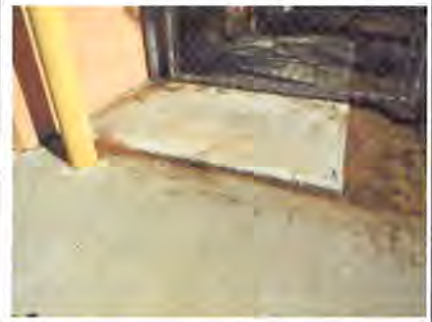
<b>ADA Standard Reference:</b>	<b>404.2.7</b>
<b>Estimated Cost:</b>	<b>\$186.66</b>
<b>Priority Level:</b>	<b>Low</b>
<b>Barrier Description/Proposed Solution:</b> The existing main entry door has a knob type lockset. An estimate has been developed to remove and replace the existing knob type lockset with a lever type lockset.

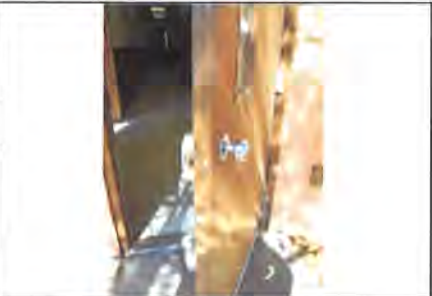
<b>ADA Standard Reference:</b>	<b>404.2.8</b>
<b>Estimated Cost:</b>	<b>\$108.35</b>
<b>Priority Level:</b>	<b>Low</b>
<b>Barrier Description/Proposed Solution:</b> The existing entry door closes in less than 5 seconds. An estimate has been developed to adjust the door closer.

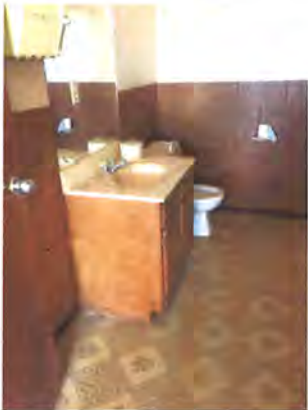
<b>ADA Standard Reference:</b>	<b>308.2, 604.4, 604.5.1, 604.5.2, 606.2</b>

<b>Estimated Cost:</b>	<b>\$5,493.15</b>	
<b>Priority Level:</b>	<b>Medium</b>	
<b>Barrier Description/Proposed Solution:</b> The restrooms in this facility have the space to allow for compliance. Both restrooms have lavatories with set in countertops with base cabinets that should be removed and replaced with new compliant fixtures (606.2). The paper towel dispensers require adjustment (308.2). The water closets require replacement due to noncompliance (604.4). Grab bars are required to be installed in accordance with this section (604.5.1, 6.4.5.2). An estimate has been developed for the items listed.

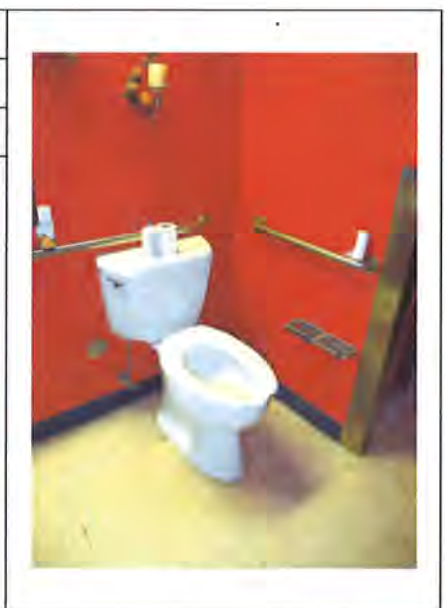
<b>ADA Standard Reference:</b>	<b>604.2, 604.5.1</b>
<b>Estimated Cost:</b>	<b>2,514.49</b>
<b>Priority Level:</b>	<b>Medium</b>

**Barrier Description/Proposed Solution:**  
The existing accessible restroom requires several work items to be in compliance. The distance of the water closet from the side wall requires adjustment (604.2). An appropriate sized sidewall grab bar requires installation at the required mounting height (604.5.1). However, the existing water closet is installed on the side of the restroom where the side wall is restricted in length by the shower enclosure. This only allows for the installation of a 24" side grab bar. The required overall length of the side wall grab bar is required to be 54" minimum. The solution would be the reconfiguration of the fixtures by flipping the location of the water closet and lavatory to the opposite walls. This will allow for the installation of the appropriate sized grab bar while maintaining the required clearances for other fixtures. An architectural design will be required. An estimate for this work has been developed.

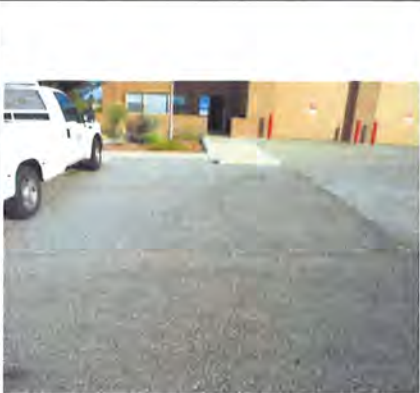
<b>ADA Standard Reference:</b>	502.2, 502.3.3, 502.6

<b>Estimated Cost:</b>	\$2,685.01	
<b>Priority Level:</b>	Low	
<b>Barrier Description/Proposed Solution:</b> The accessible parking provided does not comply with the following requirements of the referenced sections. The accessible space and access aisle do not meet the required measurements (502.2). The paint is faded and does not discourage parking in the access aisle (502.3.3). The slope of the space and access aisle exceeds 1:48 and the handicap parking sign is not mounted at the correct height (502.6). Access aisles should be painted with blue paint and include text that indicates "NO PARKING". An estimate has been developed to reconfigure the parking to comply with the requirements of the referenced sections.

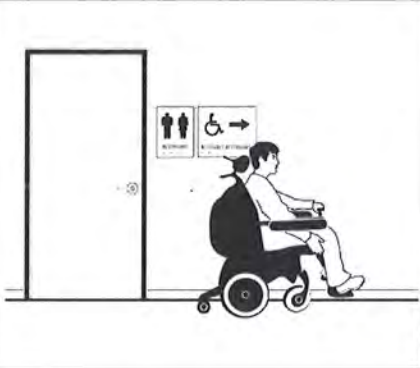
<b>ADA Standard Reference:</b>	<b>216.8, 703.4.2</b>

<b>Estimated Cost:</b>	<b>\$141.18</b>	
<b>Priority Level:</b>	<b>Low</b>	
<b>Barrier Description/Proposed Solution:</b> This facility has 2 restrooms; 1 which is accessible. A directional sign indicating the location of the accessible restroom should be installed at the inaccessible restroom. The sign installed at the accessible restroom requires horizontal relocation. An estimate has been developed for the installation of 2 new tactile text with Braille signs.

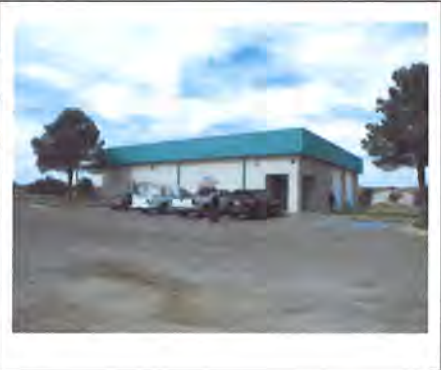
<b>ADA Standard Reference:</b>	<b>216.6</b>
<b>Estimated Cost:</b>	<b>\$166.32</b>
<b>Priority Level:</b>	<b>Low</b>
<b>Barrier Description/Proposed Solution:</b> This facility has 2 entrances. A directional sign needs to be installed indicating the direction of the main accessible entrance and a sign needs to be installed at the accessible entrance indicating ADA accessibility. An estimate has been developed for the installation of the signs.

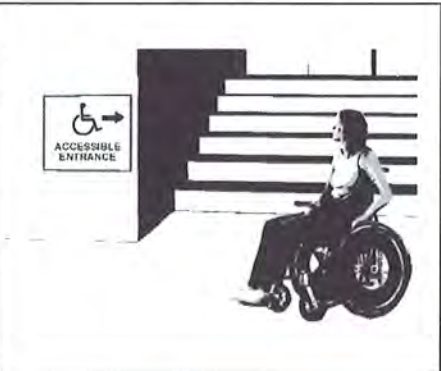
<b>ADA Standard Reference:</b>	<b>404.2.7</b>
<b>Estimated Cost:</b>	<b>572.74</b>
<b>Priority Level:</b>	<b>Medium</b>
<b>Barrier Description/Proposed Solution:</b> The existing entry door requires minor work items to be in compliance with the referenced section. The existing door is equipped with a knob type lockset and requires replacement to a lever type lockset. The door also closes in less than 5 seconds and the door closer be adjusted. An estimate has been developed for the work items noted.

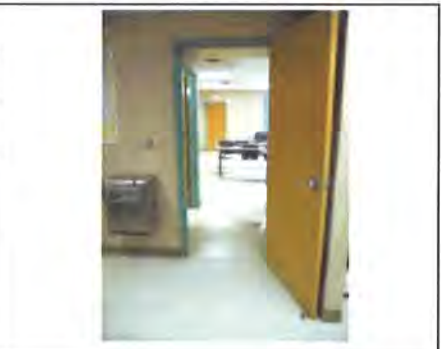
<b>ADA Standard Reference:</b>	<b>404.2.7</b>
<b>Estimated Cost:</b>	<b>\$539.37</b>
<b>Priority Level:</b>	<b>Medium</b>
<b>Barrier Description/Proposed Solution:</b> The existing doors at the entry, kitchen, and office currently have knob type locksets installed and require replacement with lever type locksets. An estimate has been developed for the installation of 3 lever type locksets.

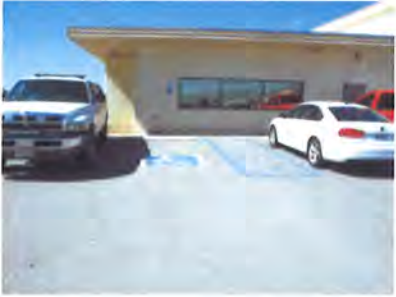
<b>ADA Standard Reference:</b>	<b>208.2.4, 208.3.1, 502.6</b>

<b>Estimated Cost:</b>	<b>\$4,713.58</b>	
<b>Priority Level:</b>	<b>Low</b>	
<b>Barrier Description/Proposed Solution:</b> The existing accessible parking is not currently "van accessible", nor is it closest to the nearest accessible entrance. An estimate has been developed for the reconfiguration of the parking striping to align the accessible space and access aisle with the entrance. Access aisles should be painted with blue paint and include text that indicates "NO PARKING".

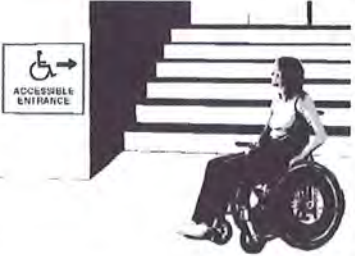
<b>ADA Standard Reference:</b>	<b>216.6</b>

<b>Estimated Cost:</b>	<b>\$91.30</b>	
<b>Priority Level:</b>	<b>Low</b>	
<b>Barrier Description/Proposed Solution:</b>		
<p>The existing inaccessible entrance does not have a sign indicating the location of the nearest accessible exit. An estimated as been developed to install a directional sign.</p>

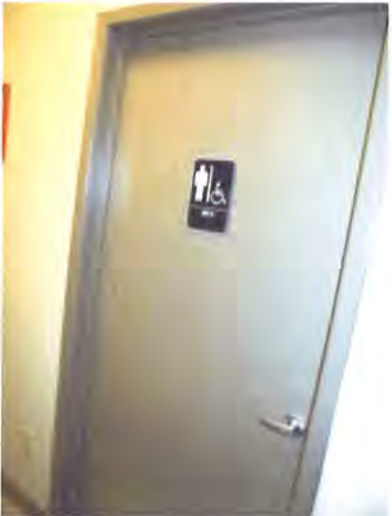
<b>ADA Standard Reference:</b>	<b>306.3.3, 308.2, 604.5.1, 604.5.2, 604.6, 606.5, 703.4.2</b>

<b>Estimated Cost:</b>	<b>\$1,891.16</b>	
<b>Priority Level:</b>	<b>Medium</b>	
<b>Barrier Description/Proposed Solution:</b>		
<p>Several work items in the existing accessible restrooms are required for compliance with the referenced sections. The restroom signs require relocation to the appropriate mounting area (703.4.2). Both restrooms soap and towel dispensers should be adjusted to the appropriate mounting height (308.2). The lavatories require vertical adjustment (306.3.3). The existing piping under the lavatory requires insulation to protect against contact (606.5). The sidewall grab bars require replacement to the appropriate 42" bar height (604.5.1). The rear grab bar requires replacement to the appropriate 36" bar height (604.5.2). The flush control on the water closet requires relocation to the open side of the unit (604.6). An estimate has been developed for the work items listed.</p>

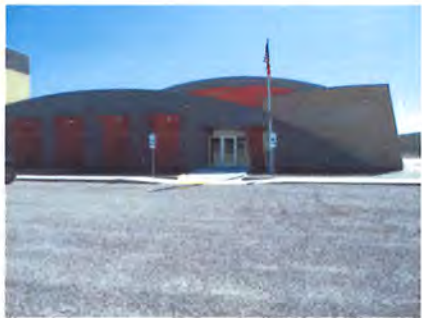
<b>ADA Standard Reference:</b>	<b>502</b>

<b>Estimated Cost:</b>	<b>\$1,901.63</b>	
<b>Priority Level:</b>	<b>Medium</b>	
<b>Barrier Description/Proposed Solution:</b> Space for accessible parking has been designed and provided; however, the surface of the parking area is a gravel/base course material that does not comply with the requirements of the referenced section. An estimate has been developed for the installation of a concrete pad and ADA specific pavement markings. New access aisles should be painted with blue paint and include text that indicates "NO PARKING".

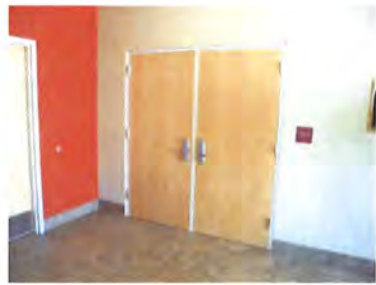
<b>ADA Standard Reference:</b>	<b>404.2.9, 404.2.8.1</b>

<b>Estimated Cost:</b>	<b>\$216.70</b>	
<b>Priority Level:</b>	<b>Low</b>	
<b>Barrier Description/Proposed Solution:</b> Room 102 has double doors that require a considerable amount of effort to open (more than 5 lbs of force) and close in less than 5 seconds. An estimate has been developed for the adjustment of the door closers.

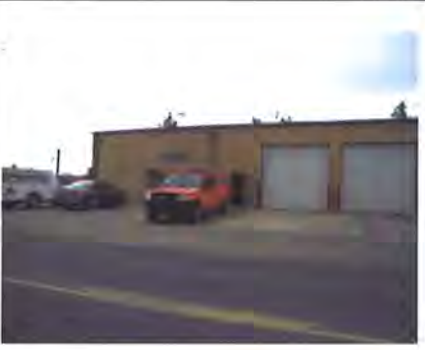
<b>Estimated Cost:</b>	<b>\$5,882.93</b>	
<b>Priority Level:</b>	<b>Medium</b>	
<b>Barrier Description/Proposed Solution:</b> The existing accessible parking requires reconfiguration to comply with the requirements of the referenced sections. Work items to include: removal and replacement of the existing heaving asphalt, restriping, and installation of a new ADA parking sign. Access aisles should be painted with blue paint and include text that indicates "NO PARKING".

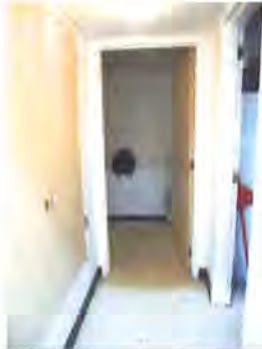
<b>ADA Standard Reference:</b>	<b>216.8, 703.4.2</b>

<b>Estimated Cost:</b>	<b>\$194.22</b>	
<b>Priority Level:</b>	<b>Low</b>	
<b>Barrier Description/Proposed Solution:</b> This facility has 2 restrooms; 1 is accessible. A directional sign indicating the location of the accessible restroom should be installed at the inaccessible restroom. The sign installed at the accessible restroom requires horizontal relocation. An estimate has been developed for the work items listed.

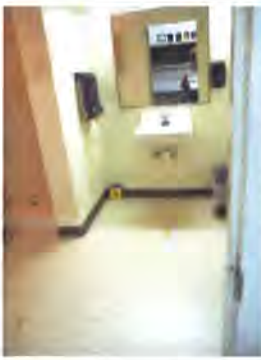
<b>ADA Standard Reference:</b>	<b>603.3, 604.5.1, 604.5.2</b>

<b>Estimated Cost:</b>	<b>\$223.42</b>	
<b>Priority Level:</b>	<b>Low</b>	
<b>Barrier Description/Proposed Solution:</b> Several work items in the existing accessible restroom are required for compliance with the referenced sections. The existing sidewall grab bar requires horizontal adjustment (603.3). The existing soap dispenser requires vertical adjustment (604.5.1). An estimate has been developed for the work items listed.

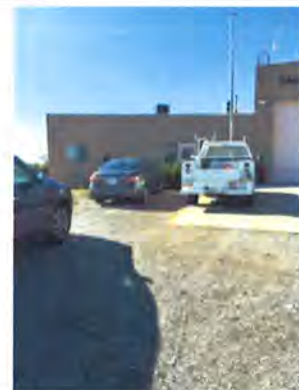
<b>ADA Standard Reference:</b>	<b>502.2, 502.6</b>
<b>Estimated Cost:</b>	<b>\$7,019.21</b>
<b>Priority Level:</b>	<b>Medium</b>
<b>Barrier Description/Proposed Solution:</b> This facility does not have any identified parking spaces provided, nor does it designate any accessible spaces. It is recommended that a new concrete pad be installed to provide for 1 new accessible parking space with an access aisle and new handicap parking sign. Access aisles should be painted with blue paint and include text that indicates "NO PARKING". An estimate has been developed for these work items listed.

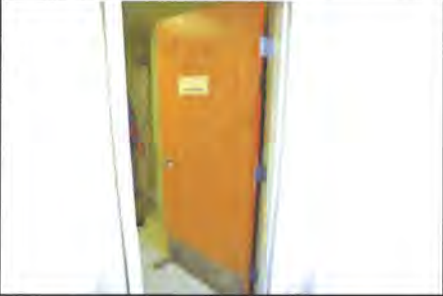
<b>ADA Standard Reference:</b>	703.2, 703.3, 703.4.2, 703.5,

<b>Estimated Cost:</b>	\$76.32	
<b>Priority Level:</b>	Medium	
<b>Barrier Description/Proposed Solution:</b> The existing restroom requires the installation of a new sign. An estimate has been developed for the installation of a new tactile text with Braille sign.

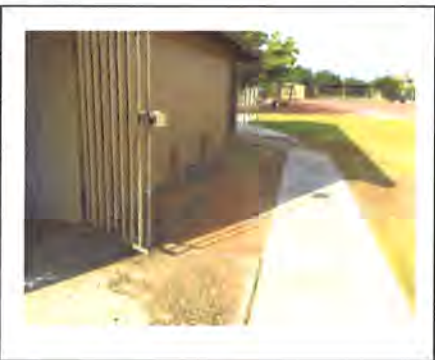
<b>ADA Standard Reference:</b>	<b>403.5.3</b>

<b>Estimated Cost:</b>	<b>\$163.42</b>	
<b>Priority Level:</b>	<b>Medium</b>	
<b>Barrier Description/Proposed Solution:</b>		
<p>There is a transition in the side walk near the restroom building that does not allow for passing space. This transition is also obstructed by sediments and overgrowth of the grass. An estimate has been developed for the installation of a new 60"x60" concrete pad to allow for passing at this transition.</p>

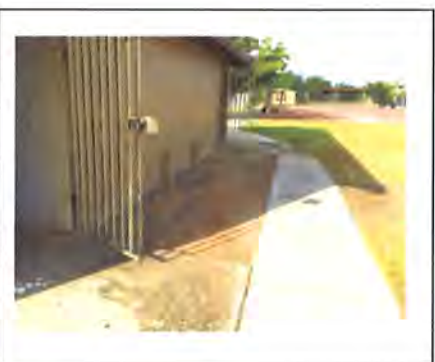
<b>Estimated Cost:</b>	<b>\$326.28</b>	
<b>Priority Level:</b>	<b>Medium</b>	
<b>Barrier Description/Proposed Solution:</b>		
<p>The restroom entrances have slopes that exceed 1:48. The concrete in these areas is also worn. An estimate has been developed for the removal of the existing concrete and the installation of a new walk that is no steeper than 1:48 between the side walk and the restroom entrances.</p>

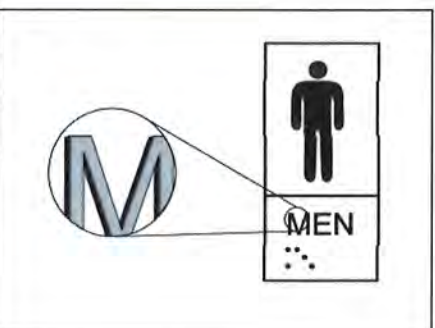
<b>Estimated Cost:</b>	<b>\$141.18</b>	
<b>Priority Level:</b>	<b>Low</b>	
<b>Barrier Description/Proposed Solution:</b>		
<p>The existing restrooms require new tactile text with Braille signs that indicate accessibility. An estimate has been developed for the installation of new ADA compliant signs.</p>

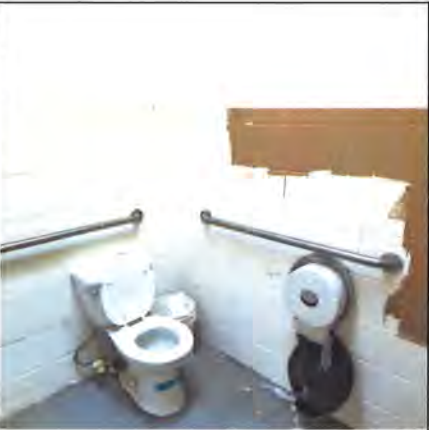
<b>ADA Standard Reference:</b>	<b>604.4, 604.8.1.1, 604.8.1.2, 606.4, 606.5</b>

<b>Estimated Cost:</b>	<b>\$3,036.26</b>	
<b>Priority Level:</b>	<b>Medium</b>	
<b>Barrier Description/Proposed Solution:</b> The 2 existing restrooms require several work items to comply with the referenced sections. The work required is as follows: The existing lavatories require pipe insulation to protect against contact (606.5). Faucets on the lavatories are knob type and require new lever type faucets (606.4). The existing water closets are operational, but dated and do not comply with the required seat height (604.4). The water closet compartment widths do not comply with the requirements of this section (604.8.1.1). The partition doors are not self-closing (604.8.1.2). An estimate has been developed to address the items required in each of the restrooms.

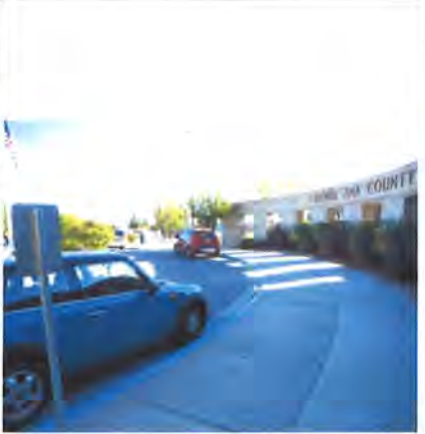
<b>ADA Standard Reference:</b>	<b>208.2</b>

<b>Estimated Cost:</b>	<b>\$2,163.20</b>	
<b>Priority Level:</b>	<b>Low</b>	
<b>Barrier Description/Proposed Solution:</b> The facility currently provides 6 standard accessible spaces. Along the circular drive at the building entrance, the curb is painted and additional spaces are marked as accessible. ADA Standards require that if parallel accessible spaces are provided, a 5'-0" minimum access aisle on the curb side adjacent to the accessible space shall be installed. The existing width of the drive will not allow for this and still provide for through traffic. According to the requirements of the referenced section, the 6 standard accessible spaces are adequate, and there is no need for the spaces provided at the circular drive. It is recommended that the markings indicating accessibility be removed, and the curb be identified as a pickup/drop off zone only. An estimate has been developed for the work items noted.

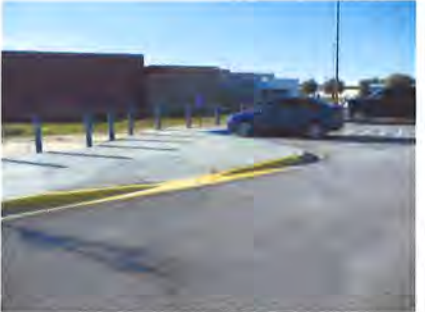
<b>Estimated Cost:</b>	<b>\$9,924.61</b>	
<b>Priority Level:</b>	<b>Medium</b>	
<b>Barrier Description/Proposed Solution:</b> The existing accessible parking spaces provided do not comply with the minimum dimensional requirements of this section, nor is there a space designated as "van accessible". The locations of the East and West accessible spaces provide 19 total spaces, 7 of which are accessible. 1 of the provided accessible spaces on the West side is only 6'-8" wide, and 5 of the spaces are located farthest from the main public entrance. It is recommended that these areas of the parking be reconfigured to provide 4 accessible spaces with 2 access aisles closest to the main public entrance on the West side, and 2 accessible spaces with 1 access aisle on the East side. 10 standard inaccessible spaces will need to be re-striped. Access aisles should be painted with blue paint and include text that indicates "NO PARKING". 3 new curb ramps will need to be installed in the existing side walk at each access aisle and new handicap signs will need to be put up. An estimate has been developed for the work items described.

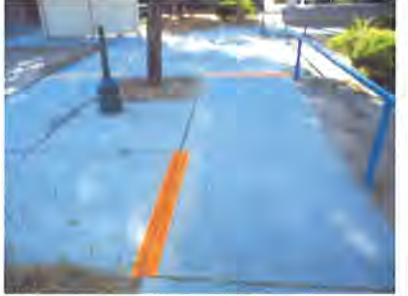
<b>ADA Standard Reference:</b>	<b>302.1</b>

<b>Estimated Cost:</b>	<b>\$280.00</b>	
<b>Priority Level:</b>	<b>Low</b>	
<b>Barrier Description/Proposed Solution:</b> The concrete sidewalk at the accessible route has settled and heaved at joints creating tripping hazards up to 1"high. It is recommended that the raised edges of the concrete along the route be ground down and smoothed. An estimate has been provided for the work items listed.

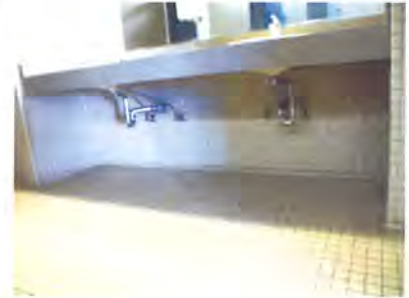
<b>ADA Standard Reference:</b>	<b>308.2.2</b>
<b>Estimated Cost:</b>	<b>\$558.55</b>
<b>Priority Level:</b>	<b>Low</b>
<b>Barrier Description/Proposed Solution:</b> Soap dispensers at the main Lobby Men's restroom, Employee Men's and Women's restrooms, and the West Officer Break room restroom need to be relocated to 44" maximum AFF. An estimate has been developed for the relocation of the soap dispensers.

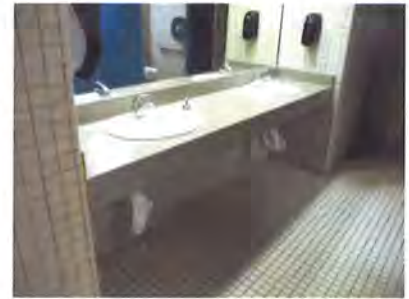
<b>ADA Standard Reference:</b>	<b>308.2</b>
<b>Estimated Cost:</b>	<b>\$446.84</b>
<b>Priority Level:</b>	<b>Low</b>
<b>Barrier Description/Proposed Solution:</b> Towel dispensers at the East Men's and Women's restrooms and the main lobby Men's and Women's restrooms need to be relocated to 44" maximum AFF. An estimate has been developed for the relocation of the towel dispensers.

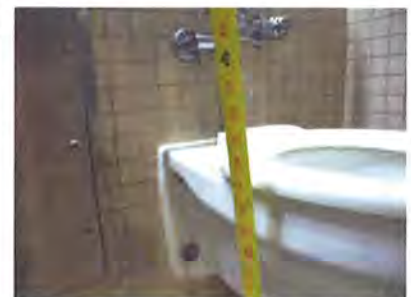
<b>ADA Standard Reference:</b>	<b>604.5.1, 604.5.2</b>	
<b>Estimated Cost:</b>	<b>\$446.84</b>	
<b>Priority Level:</b>	<b>Low</b>	
<b>Barrier Description/Proposed Solution:</b>		
<p>The sidewall grab bars in the employee restrooms and the rear wall grab bars in the East Lobby Women's restroom require horizontal adjustment to comply with the mounting requirements of this section. An estimate has been developed for the adjustment of the grab bars.</p>

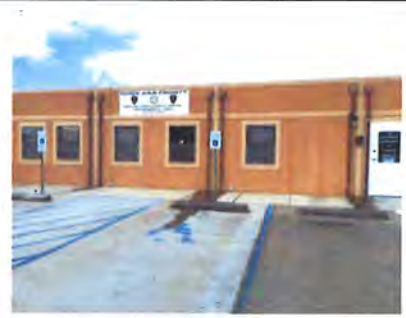
<b>ADA Standard Reference:</b>	<b>502.6</b>
<b>Estimated Cost:</b>	<b>\$313.80</b>
<b>Priority Level:</b>	<b>Low</b>
<b>Barrier Description/Proposed Solution:</b> 1 of 2 accessible parking signs requires height adjustment. An estimate has been developed for the installation of a new ADA sign.

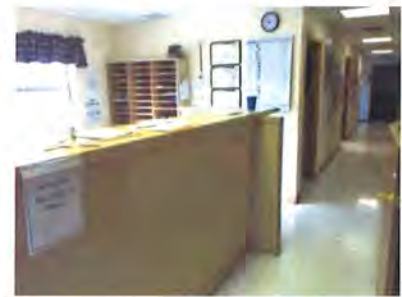
<b>ADA Standard Reference:</b>	<b>904.4.1</b>
<b>Estimated Cost:</b>	<b>\$3,322.66</b>
<b>Priority Level:</b>	<b>Medium</b>
<b>Barrier Description/Proposed Solution:</b> The existing reception counter at the entrance is 50" AFF. A section of the counter, at least 36" long, should be provided no higher than 36" AFF. An estimate has been developed for the removal and installation of a new reception counter.

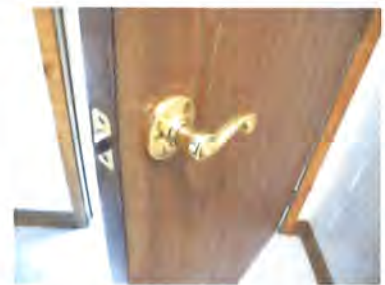
<b>ADA Standard Reference:</b>	<b>404.2.7</b>
<b>Estimated Cost:</b>	<b>\$373.32</b>
<b>Priority Level:</b>	<b>Low</b>
<b>Barrier Description/Proposed Solution:</b> The existing locksets on both restroom doors have locks that require a pinching and twisting motion to operate. An estimate has been developed for the replacement of the locksets.

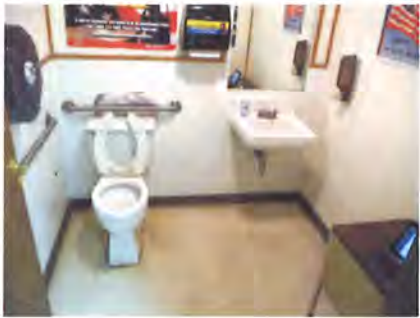
<b>Estimated Cost:</b>	\$895.23	
<b>Priority Level:</b>	Medium	
<b>Barrier Description/Proposed Solution:</b>		
<p>The existing restrooms require minor work items to comply with the requirements of the referenced sections. Both restrooms require that pipe insulation be installed below the sinks to protect against contact (606.5). Both restrooms require that the paper towel dispensers be adjusted to the appropriate mounting height (308.2). The side wall grab bars in both restrooms require horizontal mounting adjustment (604.5.1). The rear wall grab bars in both restrooms require replacement with a 36" bar (604.5.2). The water closet in the Men's restroom requires the flush control be relocated to the open side of the unit (604.6). An estimate has been developed for the work items listed.</p>

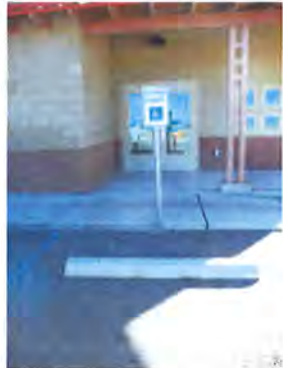
<b>ADA Standard Reference:</b>	208.2.4, 502.6

<b>Estimated Cost:</b>	\$627.60	
<b>Priority Level:</b>	Low	
<b>Barrier Description/Proposed Solution:</b>		
<p>The existing parking provides for 2 accessible parking spaces. While the existing spaces are large enough to be considered "van accessible", neither is identified as such. The signs that are provided are also mounted below the minimum required height. An estimate has been developed for the replacement of both signs to comply with the requirements of the referenced sections.</p>

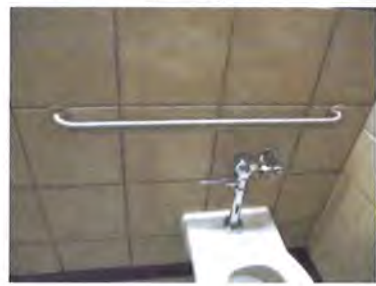
<b>ADA Standard Reference:</b>	<b>604.5.2</b>

<b>Estimated Cost:</b>	<b>\$216.70</b>	
<b>Priority Level:</b>	<b>Low</b>	
<b>Barrier Description/Proposed Solution:</b>		
<p>The rear grab bars at the accessible stalls in both restrooms require adjustment to comply with the mounting requirements of the referenced section. An estimate has been developed for the horizontal adjustment of the grab bars.</p>

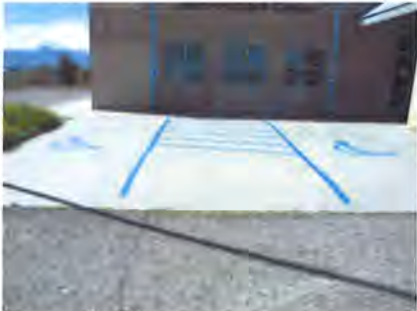
<b>ADA Standard Reference:</b>	<b>208.2.4, 502.3.3, 502.6</b>

<b>Estimated Cost:</b>	<b>\$752.88</b>	
<b>Priority Level:</b>	<b>Low</b>	
<b>Barrier Description/Proposed Solution:</b>		
<p>The existing accessible parking requires the following work items to be in compliance with the requirements of the referenced sections. The existing configuration of the parking spaces allows for “van accessibility”; however, there is not a sign provided indicating that the space is “van accessible” (208.2.4). The signs are mounted too low and are faded (502.6). The access aisle gore lines are incomplete (502.3.3). An estimate has been developed for the installation of new signs and the completion of the gore lines at the access aisle. Access aisles should be painted with blue paint and include text that indicates “NO PARKING”.</p>

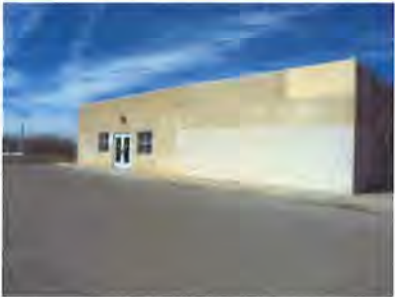
<b>ADA Standard Reference:</b>	<b>216.6</b>

<b>Estimated Cost:</b>	<b>\$189.74</b>	
<b>Priority Level:</b>	<b>Low</b>	
<b>Barrier Description/Proposed Solution:</b>		
<p>A sign at the south side entrance indicating the direction of the nearest accessible entrance, as well as a sign indicating that the main entrance is accessible require installation. An estimate has been developed for the installation of 2 new ADA compliant signs.</p>

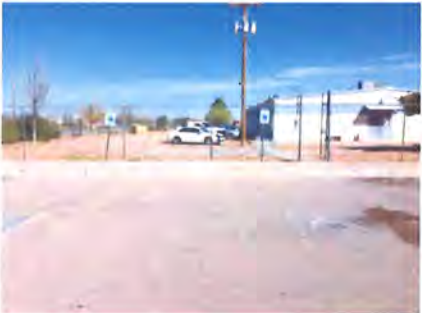
<b>ADA Standard Reference:</b>	<b>502.2, 502.3, 502.6</b>

<b>Estimated Cost:</b>	<b>\$3,632.56</b>	
<b>Priority Level:</b>	<b>Medium</b>	
<b>Barrier Description/Proposed Solution:</b> The accessible parking requires multiple work items to be in compliance with the referenced sections. The existing configuration of the accessible parking does not provide an access aisle (502.2, 502.3). The existing ADA signs do not designate "van accessibility" and are not mounted at the appropriate height (502.6). An estimate has been developed to reconfigure the parking to allow for two 8' accessible spaces with an 8' access aisle in the middle. Access aisles should be painted with blue paint and include text that indicates "NO PARKING". Wheel stops should be installed 5' from the existing curb to provide for an accessible route from the parking area to the main entrance.

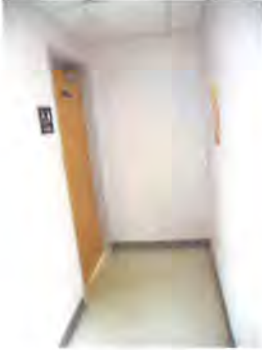
<b>ADA Standard Reference:</b>	<b>703.4.1</b>

<b>Estimated Cost:</b>	<b>\$135.08</b>	
<b>Priority Level:</b>	<b>Low</b>	
<b>Barrier Description/Proposed Solution:</b> The sign at the Lobby Restroom is noncompliant. The sign is mounted at the wrong height and requires relocation. An estimate has been developed for the relocation of the sign to the appropriate mounting height.

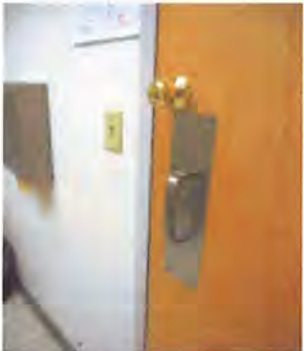
<b>ADA Standard Reference:</b>	<b>404.2.7, 404.2.8.1</b>

<b>Estimated Cost:</b>	<b>\$746.64</b>	
<b>Priority Level:</b>	<b>Low</b>	
<b>Barrier Description/Proposed Solution:</b> The existing Lobby Restroom door has several issues that make it noncompliant. The knob type lockset is mounted too high and the door closes in less than 5 seconds. An estimate has been developed for the removal of the knob type lockset and push/plate, installation of lever type locksets, and adjustment of the door closer.

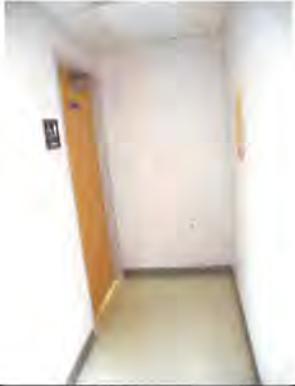
<b>ADA Standard Reference:</b>	<b>309.4, 603.4, 604.8.1.1, 604.8.1.2, 606.5</b>

<b>Estimated Cost:</b>	<b>\$495.64</b>	
<b>Priority Level:</b>	<b>Low</b>	
<b>Barrier Description/Proposed Solution:</b> The Lobby Restroom requires multiple work items to be compliant. The lavatories require pipe insulation to protect against contact (606.5). The coat hooks in the accessible stalls require vertical adjustment (603.4). The doors to the accessible stall are not self-closing (604.8.1.2). The door to the accessible stall in the Women’s restroom is missing hardware (309.4). The existing accessible stalls are less than 60” wide (604.8.1.1) An estimate has been developed for the items listed.

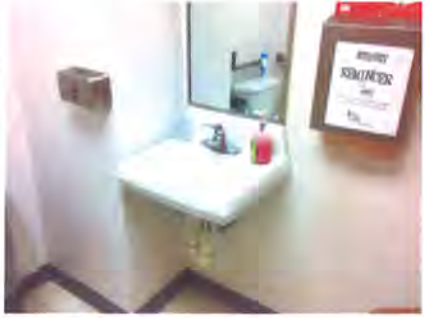
<b>Estimated Cost:</b>	<b>\$608.73</b>	
<b>Priority Level:</b>	<b>Low</b>	
<b>Barrier Description/Proposed Solution:</b> Several work items in the existing Men’s Staff restroom are required for compliance with the referenced sections. The swing of the door needs to be flipped to provide adequate maneuvering clearance beyond the latch side of the door (404.2.4). The existing side wall grab bar requires horizontal adjustment (604.5.1). The flush control on the water closet requires relocation to the open side of the unit (604.6). The pipes under the lavatory need to be insulated to protect against contact (606.5). An estimate has been developed for the listed work items.

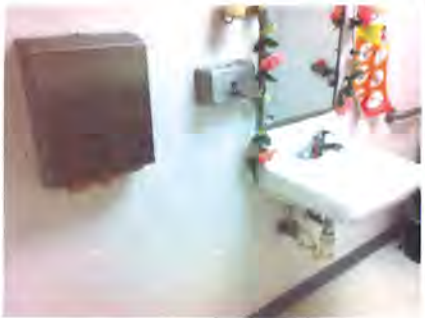
<b>ADA Standard Reference:</b>	<b>604.5.1, 604.6, 606.5</b>

<b>Estimated Cost:</b>	<b>\$380.04</b>	
<b>Priority Level:</b>	<b>Low</b>	
<b>Barrier Description/Proposed Solution:</b> Several work items in the existing Women’s Staff restroom are required for compliance with the referenced sections. The pipes under the lavatories need to be insulated to protect against contact (606.5). The flush control on the water closet requires relocation to the open side of the unit (604.6). The existing side wall grab bar requires horizontal adjustment (604.5.1). An estimate has been developed for the listed work items.

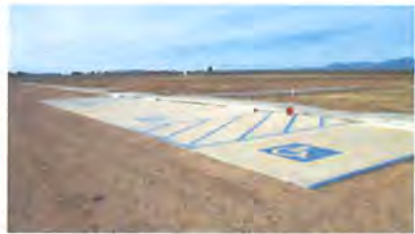
<b>ADA Standard Reference:</b>	<b>502.2, 502.6</b>

<b>Estimated Cost:</b>	<b>653.86</b>	
<b>Priority Level:</b>	<b>Low</b>	
<b>Barrier Description/Proposed Solution:</b> The existing accessible parking provided is missing 2 ADA signs. An estimate has been developed for 2 new signs; 1 of which should indicate "van accessibility".

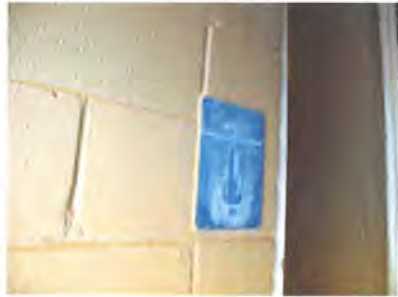
<b>ADA Standard Reference:</b>	<b>703.5</b>

<b>Estimated Cost:</b>	<b>\$141.18</b>	
<b>Priority Level:</b>	<b>Low</b>	
<b>Barrier Description/Proposed Solution:</b> Both the Men's and Women's restroom signs are faded and do not contrast with their background. An estimate has been developed for the removal and replacement of the existing signs with new tactile text and Braille signs.

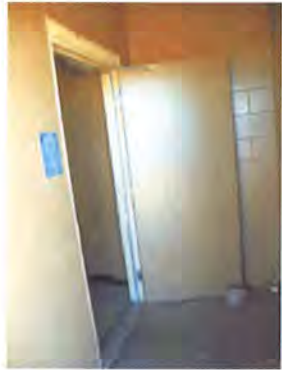
<b>ADA Standard Reference:</b>	<b>404.2.9</b>

<b>Estimated Cost:</b>	<b>\$216.70</b>	
<b>Priority Level:</b>	<b>Low</b>	
<b>Barrier Description/Proposed Solution:</b> The Men's and Women's restroom doors take a considerable amount of effort to open (more than 5lbs of force) and close in less than 5 seconds. An estimate has been developed for the adjustment of the door closers.

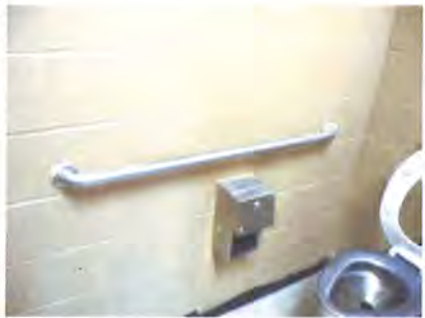
<b>Estimated Cost:</b>	<b>\$878.08</b>	
<b>Priority Level:</b>	<b>Medium</b>	
<b>Barrier Description/Proposed Solution:</b> Several work items in the existing Men's and Women's restroom are required for compliance with the referenced sections. The existing sidewall and rear wall grab bars require horizontal adjustment (604.5.1, 604.5.2). Restroom stall doors are not self-closing and require door adjustment or replacement (604.8.1.2). An estimate has been developed for the work items listed.

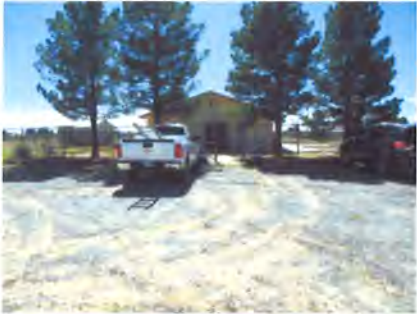
<b>ADA Standard Reference:</b>	<b>208.2</b>

<b>Estimated Cost:</b>	<b>\$4,509.48</b>	
<b>Priority Level:</b>	<b>High</b>	
<b>Barrier Description/Proposed Solution:</b> The existing gravel parking lot currently has no provision for accessible parking associated with the Community Building. ADA standards require that at least 1 accessible parking space be made available. For the purposes of this estimate, it is suggested that a new concrete pad approximately 26'x22' to accommodate 2 new accessible parking spaces with an access aisle be installed. The estimate includes the installation of signs that include the International Symbol of Accessibility, parking bumpers, and appropriate pavement markings. New access aisles should be painted with blue paint and include text that indicates "NO PARKING".
