# Doña Ana County

AMERICANS WITH DISABILITIES ACT  
SELF-EVALUATION  
AND  
TRANSITION PLAN  
DECEMBER 2017

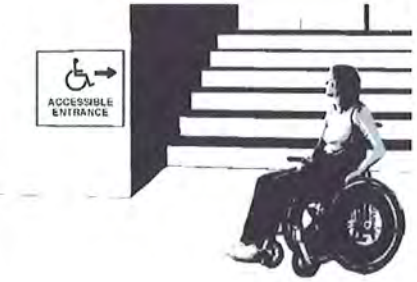
<b>ADA Standard Reference:</b>	<b>216.6</b>

<b>Estimated Cost:</b>	<b>\$86.80</b>	
<b>Priority Level:</b>	<b>Medium</b>	
<b>Barrier Description/Proposed Solution:</b> There are no existing entrance signs signifying an accessible entrance. ADA Standards require that all inaccessible entrances have signs indicating the location of the nearest accessible entrance. It is recommended that a sign be put up at the accessible entrance that includes the International Symbol of Accessibility on it. An estimate has been developed for the installation of the sign and the mounting.

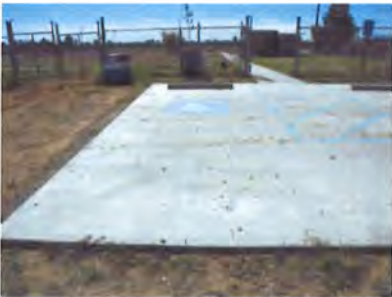
<b>ADA Standard Reference:</b>	208.2.4

<b>Estimated Cost:</b>	\$2,920.77	
<b>Priority Level:</b>	High	
<b>Barrier Description/Proposed Solution:</b> The existing accessible parking provided is not properly striped and 1 of the ADA signs is missing and requires replacement. An estimate has been developed for the reconfiguration of the spaces and installation of a new sign. Access aisles should be painted with blue paint and include text that indicates "NO PARKING".

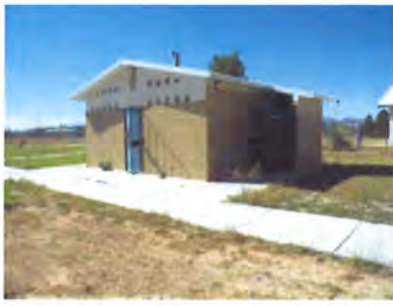
<b>ADA Standard Reference:</b>	703.5

<b>Estimated Cost:</b>	\$141.18	
<b>Priority Level:</b>	Medium	
<b>Barrier Description/Proposed Solution:</b> The existing accessible restrooms do not have tactile room signs with Braille. An estimate has been developed for the installation of new signs.

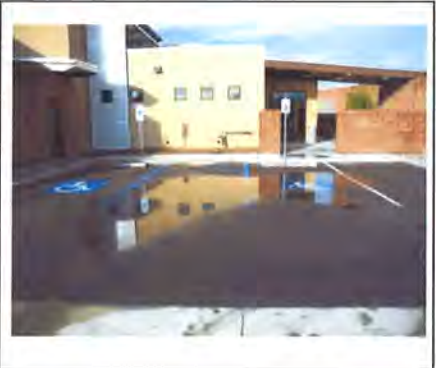
<b>ADA Standard Reference:</b>	<b>404.2.8</b>
<b>Estimated Cost:</b>	<b>\$216.70</b>
<b>Priority Level:</b>	<b>Low</b>
<b>Barrier Description/Proposed Solution:</b> The existing public entry doors close in less than 5 seconds. An estimate has been developed for the adjustment of the door closers.

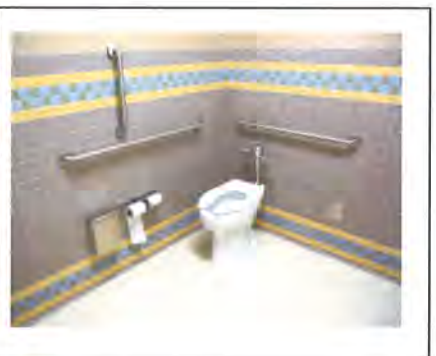
<b>ADA Standard Reference:</b>	<b>604.5.1, 604.5.2</b>
<b>Estimated Cost:</b>	<b>\$335.13</b>
<b>Priority Level:</b>	<b>Low</b>
<b>Barrier Description/Proposed Solution:</b> The side wall grab bar in restroom 106 requires horizontal adjustment and the rear wall grab bar in restrooms 106 and 112 require horizontal adjustment. An estimate has been developed for the work items listed.

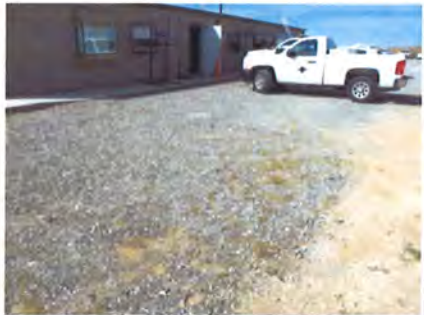
<b>ADA Standard Reference:</b>	206.2.1, 208.2, 208.2.4, 502.2, 502.3, 502.6

<b>Estimated Cost:</b>	\$4,104.75	
<b>Priority Level:</b>	High	
<b>Barrier Description/Proposed Solution:</b> The existing gravel parking lot does not provide accessible parking. An estimate has been developed to install a 26'x22' concrete pad to accommodate two 8' wide accessible spaces with an 8' access aisle. The estimate includes appropriate pavement markings, 2 ADA signs, and wheel stops. New access aisles should be painted with blue paint and include text that indicates "NO PARKING".		
<b>ADA Standard Reference:</b>	404.2.7

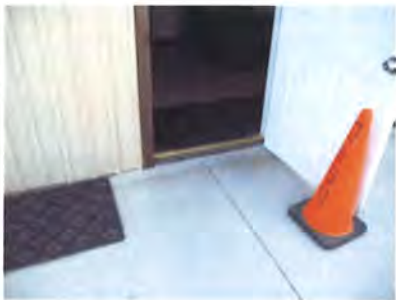
<b>Estimated Cost:</b>	\$179.79	
<b>Priority Level:</b>	Low	
<b>Barrier Description/Proposed Solution:</b> The existing entrance door has a knob type lockset and requires removal and replacement with a lever type lockset. An estimate has been developed for the item noted.

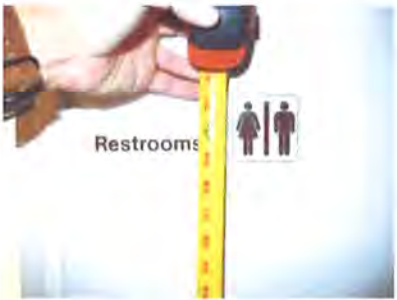
<b>ADA Standard Reference:</b>	<b>703.2, 703.3, 703.4.2, 703.4.1</b>

<b>Estimated Cost:</b>	<b>\$135.84</b>	
<b>Priority Level:</b>	<b>Low</b>	
<b>Barrier Description/Proposed Solution:</b> The existing room signs to the 2 restrooms are not ADA compliant. An estimate has been developed to install 2 new signs with tactile text and Braille.

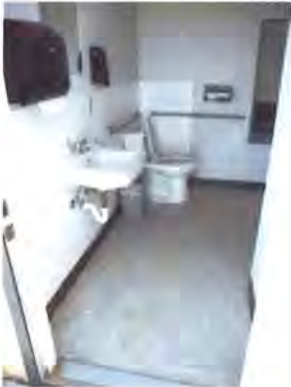
<b>ADA Standard Reference:</b>	<b>308.2, 308.2.2, 603.3, 604.5.1</b>

<b>Estimated Cost:</b>	<b>\$432.92</b>	
<b>Priority Level:</b>	<b>Low</b>	
<b>Barrier Description/Proposed Solution:</b> Several work items in the South restroom are required for compliance with the referenced sections. The existing mirror requires relocation to the required mounting height (603.3). The soap and towel dispensers require adjustment to the appropriate mounting height (308.2, 308.2.2). The existing sidewall grab bar requires horizontal adjustment (604.5.1). An estimate has been developed for the work items listed.

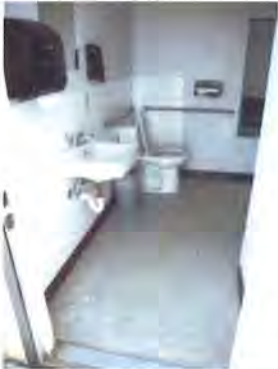
<b>ADA Standard Reference:</b>	<b>308.2, 308.2.2, 603.3, 604.5.1</b>

<b>Estimated Cost:</b>	<b>\$432.92</b>	
<b>Priority Level:</b>	<b>Low</b>	
<b>Barrier Description/Proposed Solution:</b> Several work items in the North restroom are required for compliance with the referenced sections. The existing mirror requires relocation to the required mounting height (603.3). The soap and towel dispensers require adjustment to the appropriate mounting height (308.2, 308.2.2). The existing sidewall grab bar requires horizontal adjustment (604.5.1). An estimate has been developed for the work items listed.

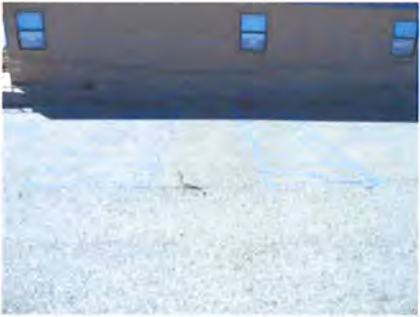
<b>ADA Standard Reference:</b>	208.2.4, 502.2, 502.6

<b>Estimated Cost:</b>	\$3,334.17	
<b>Priority Level:</b>	Low	
<b>Barrier Description/Proposed Solution:</b> The existing parking lot provides 2 accessible spaces with 2 access aisles. The access aisles do not align with the ramps. An estimate has been developed for the reconfiguration of the accessible parking to have two 8'-0" wide spaces, with an 8'-0" wide access aisle aligned with the ramp entrance. Access aisles should be painted with blue paint and include text that indicates "NO PARKING". New accessible parking signs should also be installed.

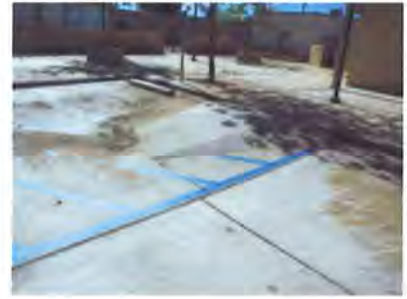
<b>ADA Standard Reference:</b>	<b>406.4</b>
<b>Estimated Cost:</b>	<b>\$330.53</b>
<b>Priority Level:</b>	<b>Medium</b>
<b>Barrier Description/Proposed Solution:</b> The landing at the top of the curb ramp exceeds the maximum allowable slope. An estimated has been developed to demolish the 4'x4' existing landing and install a level landing.

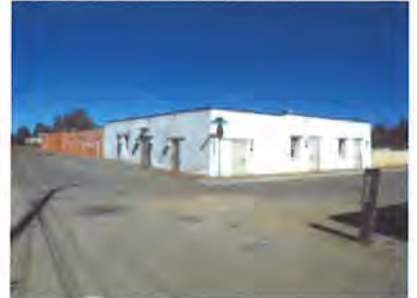
<b>ADA Standard Reference:</b>	<b>216.6</b>
<b>Estimated Cost:</b>	<b>\$118.56</b>
<b>Priority Level:</b>	<b>Low</b>
<b>Barrier Description/Proposed Solution:</b> Signs indicating the nearest accessible entrance require installation. This building is on the historic register which may provide an exception to this standard. An estimate has been developed for the installation of 2 new directional signs.

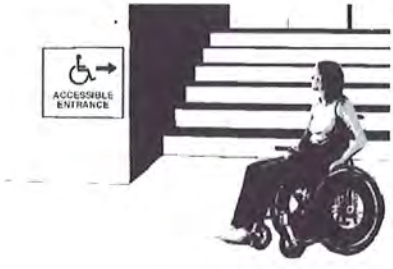
<b>ADA Standard Reference:</b>	<b>216.6</b>

<b>Estimated Cost:</b>	<b>87.19</b>	
<b>Priority Level:</b>	<b>Low</b>	
<b>Barrier Description/Proposed Solution:</b> This facility has 2 entrances. A directional sign needs to be installed indicating the direction of the main accessible entrance and a sign needs to be installed at the accessible entrance indicating ADA accessibility. An estimate has been developed for the installation of the signs.

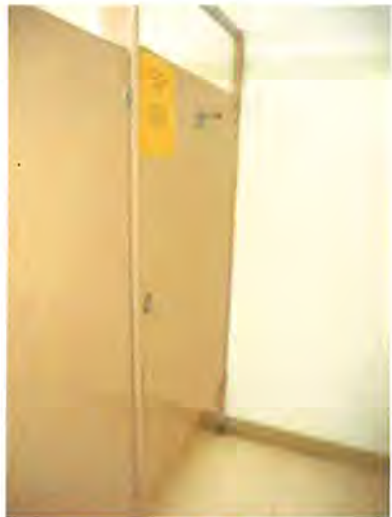
<b>Estimated Cost:</b>	<b>\$2,296.15</b>	
<b>Priority Level:</b>	<b>Medium</b>	
<b>Barrier Description/Proposed Solution:</b> Several work items in the existing Men's restroom are required for compliance with the referenced sections. The existing door to the Men's restroom requires that a tactile text with Braille sign be installed (703.5). Pipe insulation under one of the lavatories is missing and requires installation (606.5). 2 existing faucets require the installation of lever type hardware (606.4). The existing soap dispenser requires mounting adjustment (308.2). The side and rear wall grab bars require horizontal adjustment (604.5.1, 604.5.2) The accessible stall partition door requires adjustment or replacement to achieve self-closing (604.8.1.2). The accessible stall is less than the minimum required width and requires reconfiguration (604.8.1.1). An estimate has been developed for the work items listed.

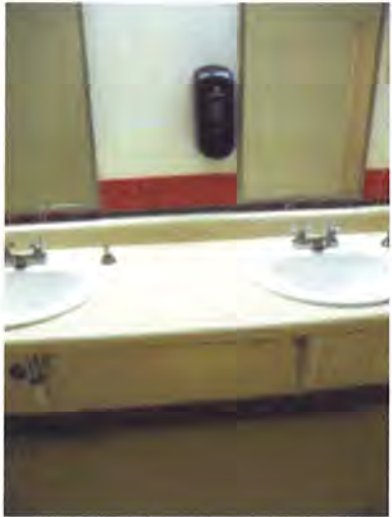
<b>Estimated Cost:</b>	<b>\$2,524.94</b>	
<b>Priority Level:</b>	<b>High</b>	
<b>Barrier Description/Proposed Solution:</b> Several work items in the existing Women's restroom are required for compliance with the referenced sections. The existing door to the Women's restroom requires that a tactile text with Braille sign be installed (703.5). The existing accessible stall has a coat hook that is above the maximum mounting height and requires the installation of a new hook (603.4). 2 existing faucets require the installation of lever type hardware (606.4). The existing soap dispenser requires mounting adjustment (308.2). The side wall grab bar requires horizontal adjustment (604.5.1). The flush control on the water closet in the accessible stall requires relocation to the open side of the unit (604.6). The accessible stall partition door requires adjustment or replacement to achieve self-closing (604.8.1.2). The accessible stall is less than the minimum required width and requires reconfiguration (604.8.1.1). An estimate has been developed for the work items listed.

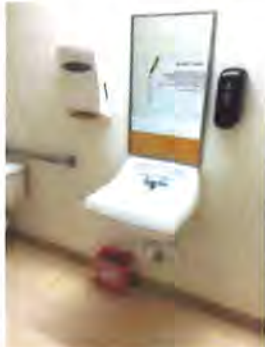
<b>ADA Standard Reference:</b>	<b>308.2, 308.2.2, 604.6</b>

<b>Estimated Cost:</b>	<b>\$451.41</b>	
<b>Priority Level:</b>	<b>Low</b>	
<b>Barrier Description/Proposed Solution:</b> Several work items in the existing Staff restroom are required for compliance with the referenced sections. The soap and paper towel dispensers require mounting adjustment (308.2, 308.2.2). The flush control on the water closet requires relocation to the open side of the unit (604.6). An estimate has been developed for the work items listed.

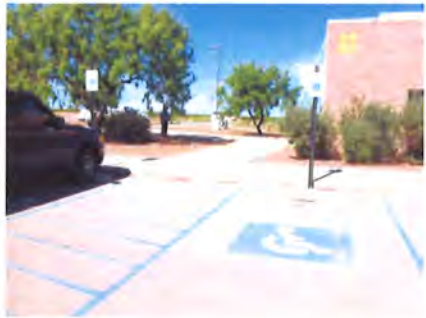
<b>ADA Standard Reference:</b>	<b>206.2.1, 502.3</b>

<b>Estimated Cost:</b>	<b>\$2,000.30</b>	
<b>Priority Level:</b>	<b>High</b>	
<b>Barrier Description/Proposed Solution:</b> The existing access aisle and accessible route requires that persons with disabilities walk behind vehicles to access the remote ramp. An estimate has been developed for the installation of a new curb ramp aligned with the existing access aisle.

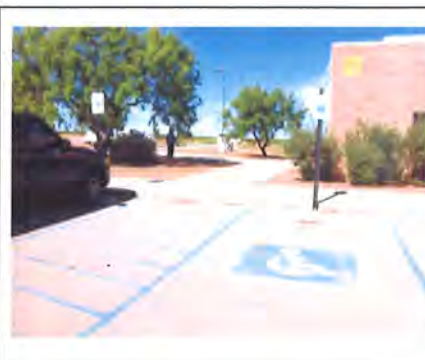
<b>ADA Standard Reference:</b>	<b>208.2.4</b>
<b>Estimated Cost:</b>	<b>\$213.97</b>
<b>Priority Level:</b>	<b>Low</b>
<b>Barrier Description/Proposed Solution:</b> The existing parking lot provides 2 accessible parking spaces; neither is designated as "van accessible". An estimate has been developed for the installation of a "van accessible" sign for identification purposes.

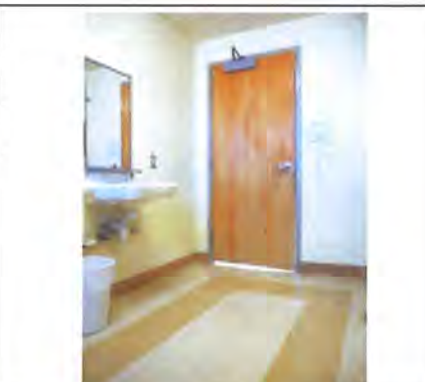
<b>ADA Standard Reference:</b>	<b>306.3.3, 308.2, 604.8.1.2</b>
<b>Estimated Cost:</b>	<b>\$473.70</b>
<b>Priority Level:</b>	<b>Medium</b>
<b>Barrier Description/Proposed Solution:</b> The existing Men's and Women's restroom require several work items to be in compliance with the referenced sections. Each restroom has a sink that is too low and requires vertical mounting adjustment (306.3.3). The existing paper towel dispensers in each restroom require relocation (308.2). The partition doors at the accessible stall in each restroom require replacement to achieve self-closing (604.8.1.2). An estimate has been developed for the items listed.

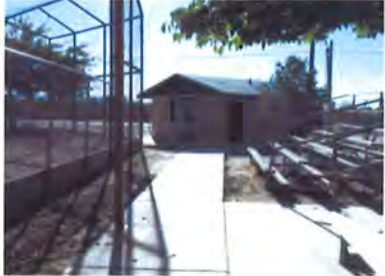
<b>ADA Standard Reference:</b>	<b>403.3</b>

<b>Estimated Cost:</b>	<b>\$536.54</b>	
<b>Priority Level:</b>	<b>Low</b>	
<b>Barrier Description/Proposed Solution:</b> The walkway between the stands and concession building is too steep (1:19). An estimate has been developed to remove the existing sidewalk and replace it with 75 S.F. of new sidewalk that has a slope of 1:20.

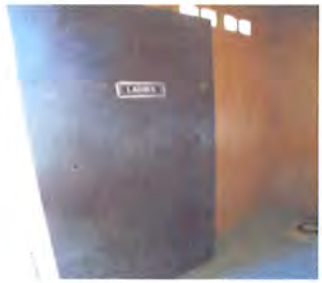
<b>ADA Standard Reference:</b>	<b>216, 404, 604, 606, 703</b>

<b>Estimated Cost:</b>	<b>\$6,167.98</b>	
<b>Priority Level:</b>	<b>High</b>	
<b>Barrier Description/Proposed Solution:</b> The existing restroom building currently does not provide for ADA accessibility. An estimate has been developed for the complete gut and redesign of 2 compliant restrooms.

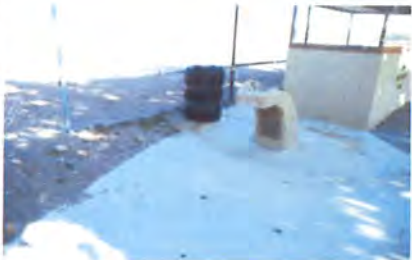
<b>ADA Standard Reference:</b>	<b>602.5</b>

<b>Estimated Cost:</b>	<b>\$3,999.96</b>	
<b>Priority Level:</b>	<b>Low</b>	
<b>Barrier Description/Proposed Solution:</b> The 2 existing water fountains are not ADA compliant. An estimate has been developed for the removal and replacement of the drinking fountains.

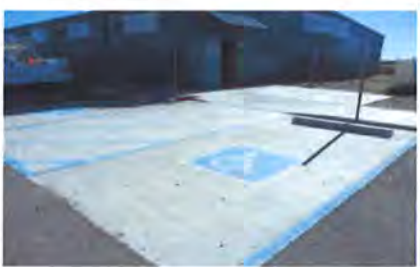
<b>ADA Standard Reference:</b>	<b>208.2.4, 502.6</b>

<b>Estimated Cost:</b>	<b>\$157.78</b>	
<b>Priority Level:</b>	<b>Low</b>	
<b>Barrier Description/Proposed Solution:</b> The accessible parking provided does not have ADA signs. An estimate has been developed for the installation of 2 new signs on the existing posts; 1 which should indicate the space as "van accessible".

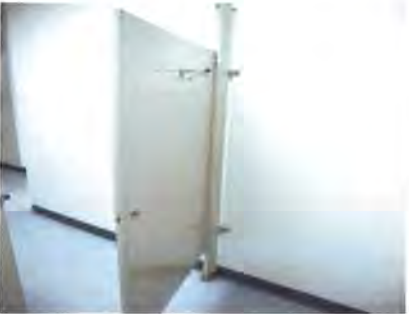
<b>ADA Standard Reference:</b>	<b>308.2.2, 603.4, 604.8.1.2</b>

<b>Estimated Cost:</b>	<b>\$352.97</b>	
<b>Priority Level:</b>	<b>Low</b>	
<b>Barrier Description/Proposed Solution:</b> The existing restroom requires several work items to be in compliance with the referenced sections. The existing coat hook is installed above the maximum allowable height and requires adjustment to the appropriate mounting height (603.4). The existing towel dispenser requires relocation (308.2). The accessible stall partition door requires adjustment or replacement to be self-closing (604.8.1.2). An estimate has been developed for the items listed.

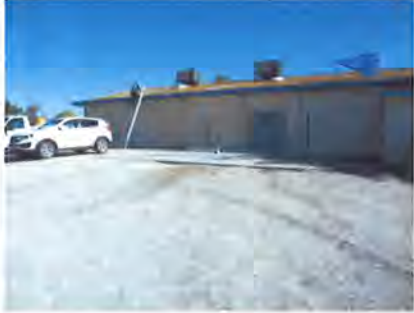
<b>ADA Standard Reference:</b>	<b>208.2.4, 502.2</b>

<b>Estimated Cost:</b>	<b>\$2,777.01</b>	
<b>Priority Level:</b>	<b>Low</b>	
<b>Barrier Description/Proposed Solution:</b> The existing accessible parking provided requires that the markings be reconfigured to provide for a "van accessible" space. An estimate has been developed for the reconfiguration of the markings to provide for two 8'-0" spaces and an 8'-0" access aisle. Access aisles should be painted with blue paint and include text that indicates "NO PARKING". A new "van accessible" sign should be installed.

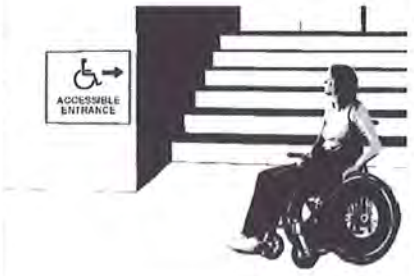
<b>ADA Standard Reference:</b>	<b>216.6</b>

<b>Estimated Cost:</b>	<b>\$94.87</b>	
<b>Priority Level:</b>	<b>Low</b>	
<b>Barrier Description/Proposed Solution:</b> A sign indicating that the West side entrance is accessible is required to be installed. An estimate has been developed for the installation of a new tactile text with Braille sign.

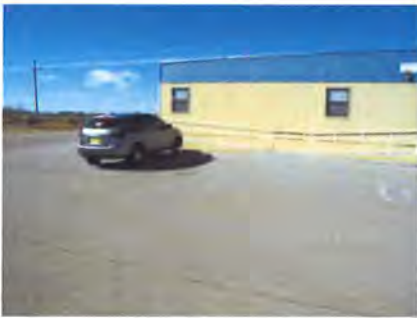
<b>ADA Standard Reference:</b>	502.3.3, 502.6

<b>Estimated Cost:</b>	\$2,348.46	
<b>Priority Level:</b>	Low	
<b>Barrier Description/Proposed Solution:</b> The existing parking striping is faded and hard to see. There are no signs signifying that the stalls are accessible. An estimate has been developed to remove the existing paint, re-paint the stalls, including the accessible aisle, and put up 2 ADA signs; 1 being a "van accessible" sign. Access aisles should be painted with blue paint and include text that indicates "NO PARKING".

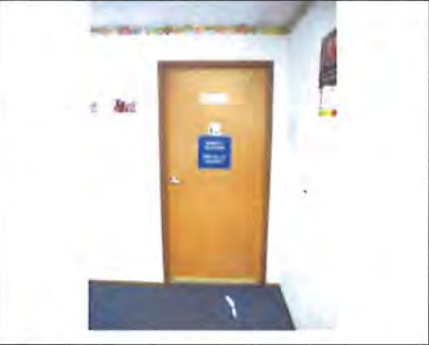
<b>ADA Standard Reference:</b>	<b>703.2, 703.3, 703.4.2</b>

<b>Estimated Cost:</b>	<b>\$152.64</b>	
<b>Priority Level:</b>	<b>Low</b>	
<b>Barrier Description/Proposed Solution:</b> This facility has 3 restrooms with room signs mounted to the doors that do not include Braille. An estimate has been developed to install 2 new tactile text with Braille signs.

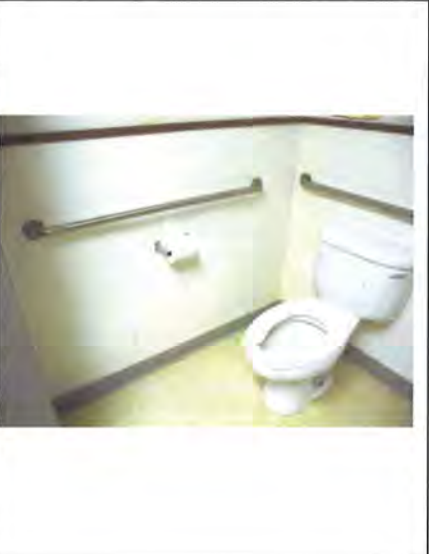
<b>ADA Standard Reference:</b>	<b>308.2, 603.4, 604.2, 604.5.2, 604.8.1.2, 609.4</b>

<b>Estimated Cost:</b>	<b>\$1,155.73</b>	
<b>Priority Level:</b>	<b>Medium</b>	
<b>Barrier Description/Proposed Solution:</b> Several work items in the existing Men's and Women's restroom are required for compliance with the referenced sections. The coat hooks are mounted above the maximum allowable height and an additional hook should be installed (603.4). The paper towel dispensers require mounting adjustment (308.2). The sidewall grab bars require vertical adjustment (609.4). The rear wall grab bars require horizontal and vertical adjustment (604.5.2, 609.4). The accessible stall partition doors require adjustment to achieve self-closing (604.8.1.2). In the Women's restroom the accessible stalls water closet requires adjustment to achieve the required distance from the sidewall (604.2). An estimate has been developed for the work items listed.

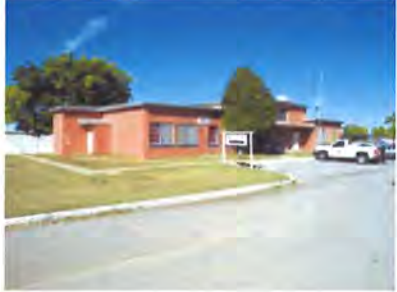
<b>ADA Standard Reference:</b>	<b>208.2</b>

<b>Estimated Cost:</b>	<b>\$2,951.55</b>	
<b>Priority Level:</b>	<b>High</b>	
<b>Barrier Description/Proposed Solution:</b> The existing parking lot does not designate an accessible parking space. An estimate has been developed to demolish 320 S.F. of asphalt and to construct a new concrete pad for a "van accessible" parking space, with an access aisle that aligns with the main entry. Access aisles should be painted with blue paint and include text that indicates "NO PARKING". This estimate includes a "van accessible" sign and post.

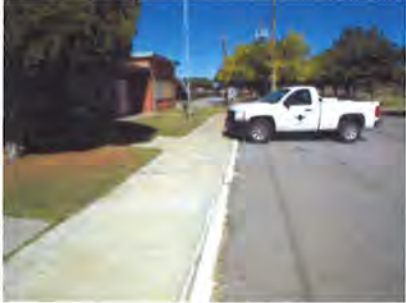
<b>ADA Standard Reference:</b>	<b>402.2, 403.3, 502.3</b>

<b>Estimated Cost:</b>	<b>\$3,431.86</b>	
<b>Priority Level:</b>	<b>Medium</b>	
<b>Barrier Description/Proposed Solution:</b> The concrete sidewalk is disintegrating and does not have an ADA curb ramp. An estimate has been developed to demolish 450 S.F. of concrete sidewalk and replace with a new sidewalk and curb ramp that is aligned with the ADA parking access aisle and main entrance. This includes the walk way to the entrance door.

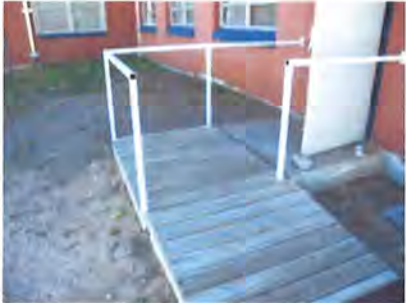
<b>ADA Standard Reference:</b>	<b>405.5</b>

<b>Estimated Cost:</b>	<b>\$5,771.72</b>	
<b>Priority Level:</b>	<b>Medium</b>	
<b>Barrier Description/Proposed Solution:</b> Wood ramps have been installed at 2 entrances of the building; the ramps do not comply with the referenced sections. The ramps should be removed and replaced with new ADA compliant concrete ramps with rails.

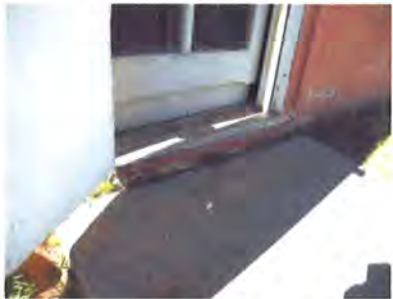
<b>ADA Standard Reference:</b>	<b>206.2.1</b>

<b>Estimated Cost:</b>	<b>\$1,441.38</b>	
<b>Priority Level:</b>	<b>High</b>	
<b>Barrier Description/Proposed Solution:</b> The main entrance to the Fair Office currently has a 3" step up at the door. A new concrete landing and ramp with railing should be installed to provide access. An estimate has been developed for the work item noted.

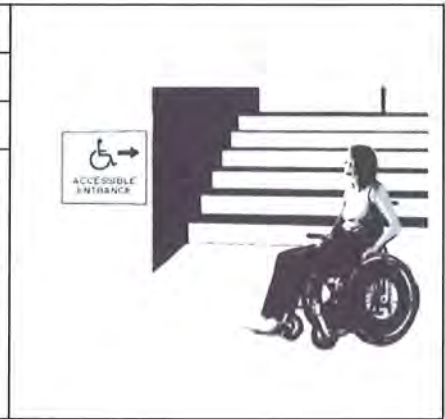
<b>ADA Standard Reference:</b>	<b>216.6</b>
<b>Estimated Cost:</b>	<b>\$101.56</b>
<b>Priority Level:</b>	<b>Low</b>
<b>Barrier Description/Proposed Solution:</b>	
At the East side of the building there are 2 entrances; the entrance to the Fair Office and the entrance at the North set of double doors. It is recommended that the set of double doors be the main accessible entrance to the facility. An estimate has been developed for the installation of 2 signs. At the Fair Office entrance a directional sign should be installed indicating the location of the nearest accessible entrance and at the set of double doors a sign indicating accessibility. An estimate has been developed for the item noted.

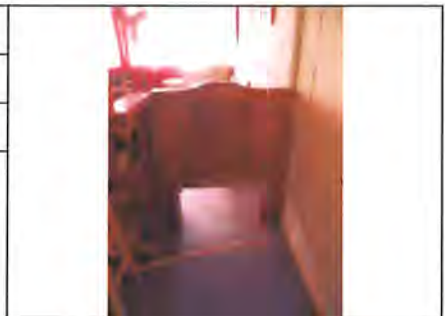
<b>ADA Standard Reference:</b>	<b>404.2.7</b>
<b>Estimated Cost:</b>	<b>\$1,078.74</b>
<b>Priority Level:</b>	<b>Medium</b>
<b>Barrier Description/Proposed Solution:</b>	
All existing interior doors (6 doors) have knob type locksets. An estimate has been developed to remove the existing knob type locksets and replace with lever type locksets.

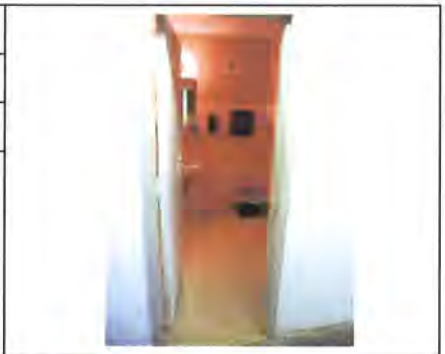
<b>ADA Standard Reference:</b>	603.3, 604.2, 604.4, 604.5.1, 604.5.2, 606.4, 606.5
<b>Estimated Cost:</b>	\$658.94
<b>Priority Level:</b>	Medium
<b>Barrier Description/Proposed Solution:</b> Several work items in the existing unisex restroom are required for compliance with the referenced sections. A room sign with tactile text and Braille requires installation (703.5).The existing mirror requires relocation to the required mounting height (603.3). The existing lavatory requires the installation of pipe insulation to protect against contact and a new ADA compliant faucet (606.5, 606.4). The water closet mounting location requires adjustment and the water closet requires replacement (604.2, 604.4). New rear and sidewall grab bars need to be installed. (604.5.1, 604.5.2). An estimate has been developed for the work items listed.

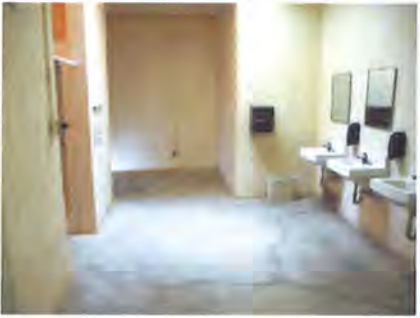
<b>ADA Standard Reference:</b>	308.2, 603.4, 604.2, 604.5.1, 606.5

<b>Estimated Cost:</b>	\$1,030.31	
<b>Priority Level:</b>	Low	
<b>Barrier Description/Proposed Solution:</b>		
<p>Several work items at the West Restroom building are required for compliance with the referenced sections. New coat hooks need to be installed at the required mounting height (603.4). The lavatories in the Women's restroom require pipe insulation below the sink to protect against contact (606.5). The paper towel dispensers in both the Men's and the Women's restrooms require vertical mounting adjustment (308.2). The water closet in the Men's accessible stall requires adjustment from the side wall to the center line (604.2). The side wall grab bars in both the Men's and Women's restrooms require replacement with the appropriate 42" bar (604.5.1). An estimate has been developed for the work items listed.</p>

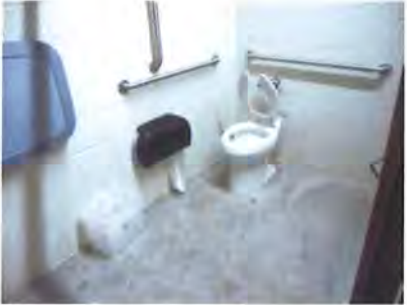
<b>ADA Standard Reference:</b>	<b>603.3, 604.5.1, 609.4</b>

<b>Estimated Cost:</b>	<b>\$1,144.09</b>	
<b>Priority Level:</b>	<b>Low</b>	
<b>Barrier Description/Proposed Solution:</b> The new restroom on the far East side of the property is relatively new construction with minor noncompliance issues that will need to be addressed to achieve full compliance with ADA Standards. 4 mirrors in both the Men's and Women's restrooms are mounted above the maximum mounting height (603.3). The sidewalls grab bars in both the Men's and the Women's accessible stalls are the wrong size and will need to be replaced (604.5.1). The rear wall grab bar in the Men's restroom accessible stall requires vertical mounting adjustment (609.4). An estimate has been developed for the work items listed.

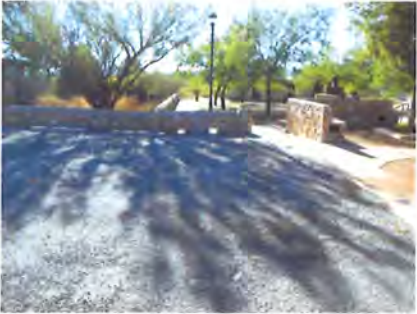
<b>Estimated Cost:</b>	<b>\$2,227.41</b>	
<b>Priority Level:</b>	<b>Medium</b>	
<b>Barrier Description/Proposed Solution:</b> The existing parking requires several work items to be in compliance with the referenced sections. The existing asphalt surface is degraded and markings are faded (502.2, 502.3.3). An ADA sign is not provided (502.6). The slope of the provided parking exceeds 1:48 and is unstable (502.4). An estimate has been developed to remove and replace the degraded asphalt surface, provide the required pavement markings for the accessible space and access aisle, and to provide a new sign and post. New access aisles should be painted with blue paint and include text that indicates "NO PARKING".

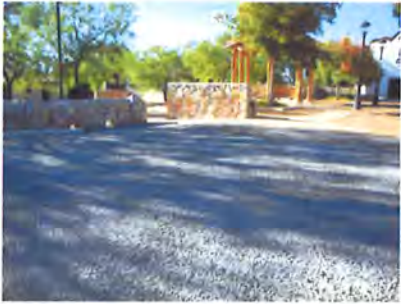
<b>ADA Standard Reference:</b>	<b>405.8</b>

<b>Estimated Cost:</b>	<b>\$3,039.60</b>	
<b>Priority Level:</b>	<b>Medium</b>	
<b>Barrier Description/Proposed Solution:</b> The accessible route has a sloped side walk or ramp that has a rise greater than 6" and requires that handrails be installed on both sides of the ramp. An estimate has been developed for the installation of the handrails.

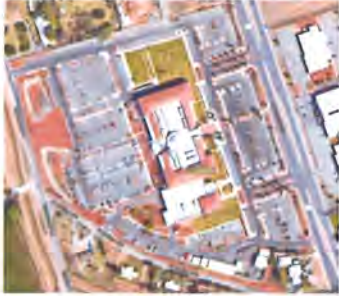
<b>ADA Standard Reference:</b>	<b>208.2, 208.2.4, 502.6</b>

<b>Estimated Cost:</b>	<b>\$1,069.85</b>	
<b>Priority Level:</b>	<b>Medium</b>	
<b>Barrier Description/Proposed Solution:</b> The main East parking lot has 20 accessible parking; 1 which is "van accessible". An estimate has been developed to install 4 "van accessible" signs at 4 of the accessible spaces to create a total of 5 "van accessible" spaces.

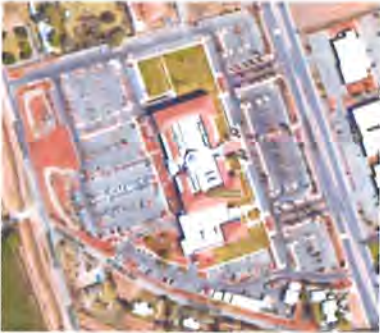
<b>ADA Standard Reference:</b>	<b>208.2, 208.2.4, 502.6</b>

<b>Estimated Cost:</b>	<b>\$855.88</b>	
<b>Priority Level:</b>	<b>Medium</b>	
<b>Barrier Description/Proposed Solution:</b> The West employee parking lot has 8 accessible parking spaces. There are also 4 accessible parking spaces inside the fenced County Vehicle parking lot on the West side of the building that are not accessible to the public. There are no "van accessible" spaces identified in the West parking lot. The existing striping has 4 spaces that could be "van accessible" parking. An estimate has been developed for the installation of new signs on 4 of the accessible spaces to designate "van accessibility".

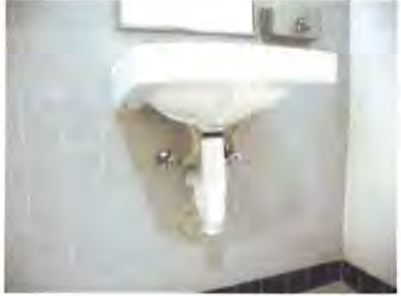
<b>ADA Standard Reference:</b>	<b>606.5</b>

<b>Estimated Cost:</b>	<b>\$35.28</b>	
<b>Priority Level:</b>	<b>Low</b>	
<b>Barrier Description/Proposed Solution:</b>		
<p>The drain is covered, but the pipes are exposed in the DA's West Men's restroom. An estimate has been developed to install ADA type insulation to the exposed pipes to protect against contact.</p>

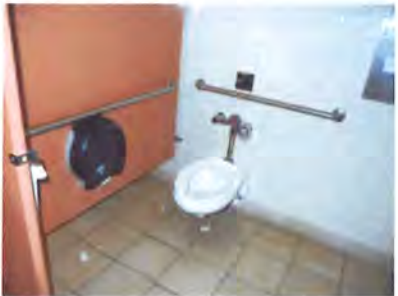
<b>ADA Standard Reference:</b>	<b>604.2</b>

<b>Estimated Cost:</b>	<b>\$2,114.55</b>	
<b>Priority Level:</b>	<b>Low</b>	
<b>Barrier Description/Proposed Solution:</b> Most of the toilets are located 1/2" to 1" too far from the side wall or partition. An estimate has been developed to adjust 9 water closets that are no less than 16" and no greater than 18" from the side wall or partition.

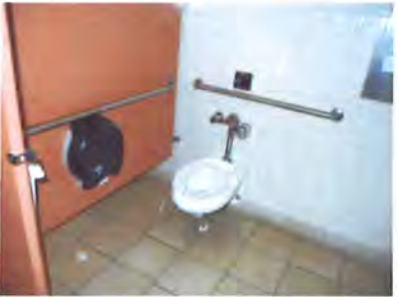
<b>ADA Standard Reference:</b>	<b>604.5.1, 604.5.2</b>

<b>Estimated Cost:</b>	<b>\$350.16</b>	
<b>Priority Level:</b>	<b>Medium</b>	
<b>Barrier Description/Proposed Solution:</b> The grab bars at the East DA's Men's and Women's restroom require replacement and adjustment as follows: The rear wall grab bar in the Men's and Women's restroom requires horizontal adjustment. The side wall grab bar in the Women's restroom requires replacement with an appropriate 42" bar. An estimate has been developed for the listed items.

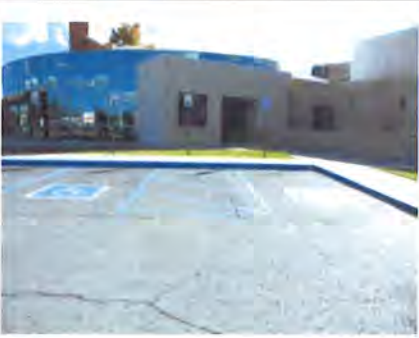
<b>ADA Standard Reference:</b>	<b>208.2.4</b>

<b>Estimated Cost:</b>	<b>\$137.34</b>	
<b>Priority Level:</b>	<b>Low</b>	
<b>Barrier Description/Proposed Solution:</b> The existing parking lot has 2 "van accessible" spaces, but they are not identified. An estimate has been developed for the installation of 2 "van accessible" signs for identification purposes.

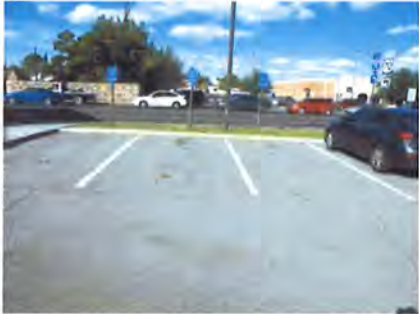
<b>ADA Standard Reference:</b>	<b>502.2, 502.3</b>

<b>Estimated Cost:</b>	<b>\$452.16</b>	
<b>Priority Level:</b>	<b>High</b>	
<b>Barrier Description/Proposed Solution:</b> On the north side of the lot there are 3 handicap spaces that do not have access aisles. For this estimate, it is suggested that 2 access aisles measuring 144 S.F. each (288 S.F. Total) be painted. However, reconfiguration of the existing accessible spaces to add an access aisle would decrease the total number of spaces provided. Access aisles should be painted with blue paint and include text that indicates "NO PARKING". Architectural design will be required.

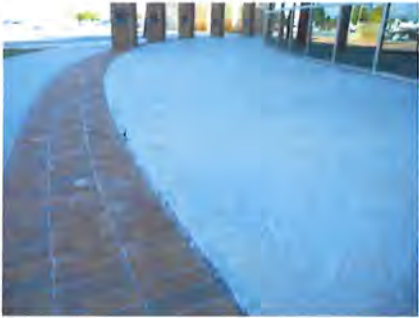
<b>Estimated Cost:</b>	<b>\$1,667.20</b>	
<b>Priority Level:</b>	<b>Low</b>	
<b>Barrier Description/Proposed Solution:</b> The existing concrete is spalling and the surface is covered with loose material. ADA Standards require that the route be stable, firm and slip-resistant. An estimate has been developed to resurface 160 S.F. of concrete. This estimate includes the concrete scarifying and the concrete topping.

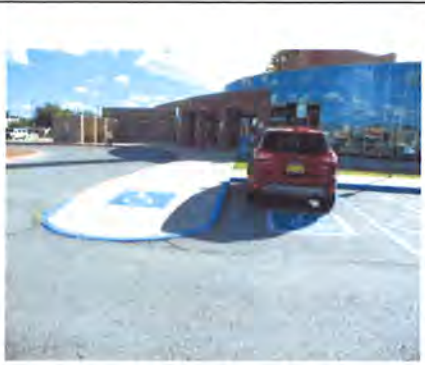
<b>Estimated Cost:</b>	<b>\$2,963.29</b>	
<b>Priority Level:</b>	<b>High</b>	
<b>Barrier Description/Proposed Solution:</b> All of the existing access aisles end in 6" curb. Curb ramps are only accessible by traveling across vehicular traffic. ADA Standards require that access aisles adjoin with an accessible route. An estimate has been developed for the construction of 2 curb ramps at the existing access aisles. The estimate includes demolition where the curb and access aisle meet and the construction of a new curb ramp with tactile warning tiles.

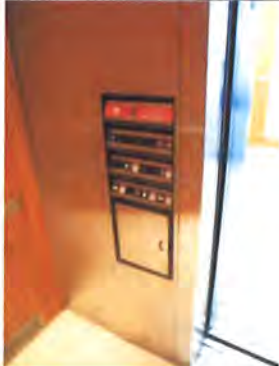
<b>ADA Standard Reference:</b>	<b>407.4.7.1, 703.2</b>

<b>Estimated Cost:</b>	<b>\$ 116.08</b>	
<b>Priority Level:</b>	<b>Medium</b>	
<b>Barrier Description/Proposed Solution:</b> The existing LULA elevator has control buttons without Braille. ADA Standards require that car control buttons be designed with Braille. An estimate has been developed for the installation of control buttons with Braille.

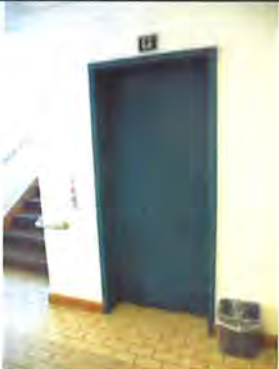
<b>ADA Standard Reference:</b>	<b>407.2.3, 408.2.3</b>

<b>Estimated Cost:</b>	<b>\$94.64</b>	
<b>Priority Level:</b>	<b>Medium</b>	
<b>Barrier Description/Proposed Solution:</b> The existing LULA elevator does not have a star on the first-floor sign. ADA Standards require that there is a sign on both door jambs on every floor identifying the floor. An estimate has been developed for the installation of 2 new tactile text with Braille signs that include stars.

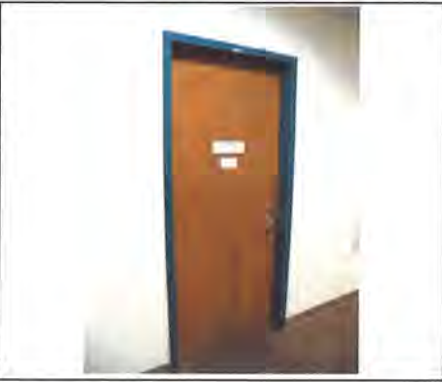
<b>ADA Standard Reference:</b>	404.2.9
<b>Estimated Cost:</b>	\$657.65
<b>Priority Level:</b>	High
<b>Barrier Description/Proposed Solution:</b> Several of the existing doors take a considerable amount of effort to open (more than 5 lbs of force). An estimate has been developed to adjust 35 door closers.

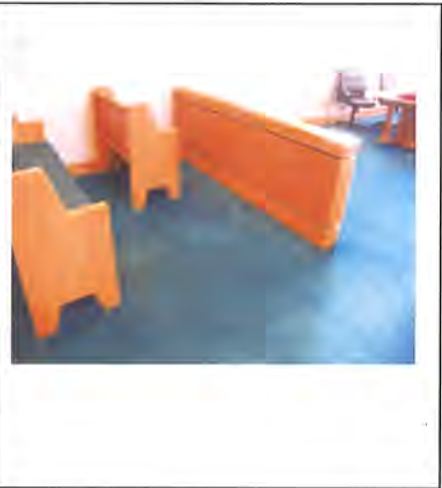
<b>ADA Standard Reference:</b>	221.2.1
<b>Estimated Cost:</b>	\$1,435.20
<b>Priority Level:</b>	Low
<b>Barrier Description/Proposed Solution:</b> The Judicial Complex has 8 courtrooms and 2 hearing rooms that have a seating capacity of approximately 46-150 spectators. All of the rooms have wooden benches for seating and all have open spaces to accommodate for wheelchairs. However, none of the spaces are identified as accessible seating. ADA Standards require that there are an adequate number of wheelchair spaces provided. An estimate has been developed to install signs where the accessible seating is located. This estimate includes the installation of 3 ADA signs in each of the 8 courtrooms and 2 hearing rooms, totaling to 30 new signs.

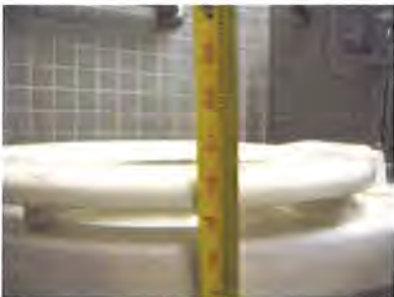
<b>ADA Standard Reference:</b>	<b>604.4</b>

<b>Estimated Cost:</b>	<b>\$714.23</b>	
<b>Priority Level:</b>	<b>Low</b>	
<b>Barrier Description/Proposed Solution:</b>		
<p>Several of the existing toilets have raised seats that are above the maximum allowable height. ADA Standards require that the height of the water closet be no less than 17" and no greater than 19" AFF. An estimate has been developed to remove and replace the existing seats with standard seats.</p>

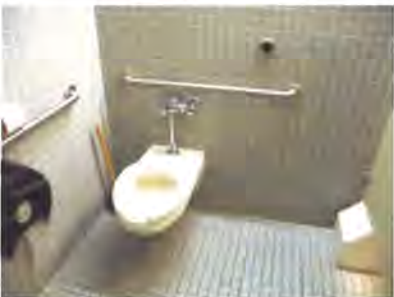
<b>ADA Standard Reference:</b>	<b>604.5.2, 609.3</b>

<b>Estimated Cost:</b>	<b>\$111.71</b>	
<b>Priority Level:</b>	<b>Low</b>	
<b>Barrier Description/Proposed Solution:</b>		
<p>The mounting heights of the grab bars, both side and rear, in Rooms 105, 253 and 257 do not comply with the requirements of this section. An estimate has been developed for the adjustment and addition of grab bars as needed.</p>

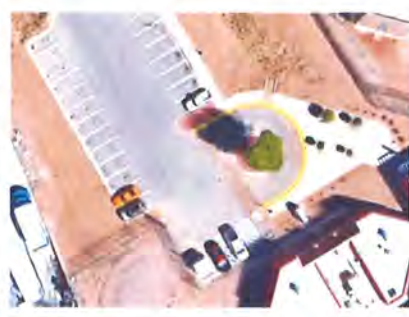
<b>ADA Standard Reference:</b>	302.1, 502.3, 502.6,

<b>Estimated Cost:</b>	\$4,971.38	
<b>Priority Level:</b>	Medium	
<b>Barrier Description/Proposed Solution:</b>  The existing location of the accessible parking is compliant and at the closest location to the building entrance. However, the accessible aisle does not adjoin an accessible route to the curb ramp provided. Individuals would have to travel behind vehicles and through traffic to get to the curb ramp. It is recommended that the 2 accessible spaces and the access aisle be relocated to the parking area just North of the roundabout drop off area and a new curb ramp installed. The access aisle should be painted with blue paint and include text that indicates "NO PARKING". The existing accessible parking would then be converted to standard spaces. An estimate has been developed for the following work items.

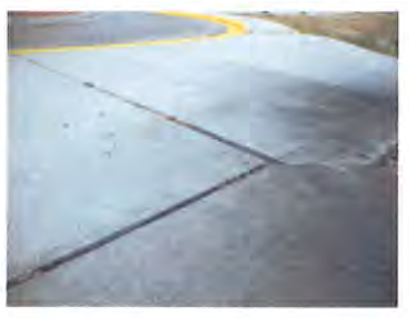
<b>Estimated Cost:</b>	\$140.00	
<b>Priority Level:</b>	Low	
<b>Barrier Description/Proposed Solution:</b>  The concrete sidewalk at the accessible route has settled and heaved at joints creating up to 1" tripping hazards. It is recommended that the raised edges of the concrete along the route be ground down and smoothed. An estimate has been provided for the work items listed.

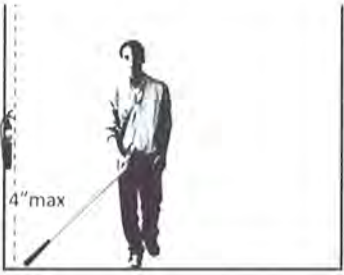
<b>ADA Standard Reference:</b>	<b>307.2</b>

<b>Estimated Cost:</b>	<b>\$299.47</b>	
<b>Priority Level:</b>	<b>Low</b>	
<b>Barrier Description/Proposed Solution:</b>		
<p>The fire extinguisher adjacent to the restrooms protrudes 8" into the circulation path. An estimate has been developed for the installation of a new fire extinguisher cabinet.</p>

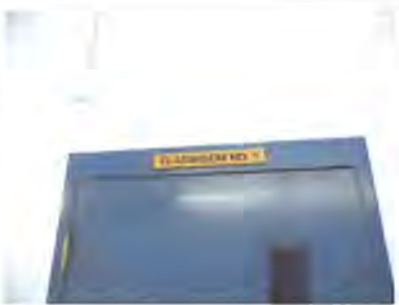
<b>ADA Standard Reference:</b>	<b>703.3</b>

<b>Estimated Cost:</b>	<b>\$211.77</b>	
<b>Priority Level:</b>	<b>Low</b>	
<b>Barrier Description/Proposed Solution:</b>		
<p>3 room signs are mounted above the doors and do not include Braille. An estimate has been developed for the installation of 3 new room tactile text with Braille signs.</p>

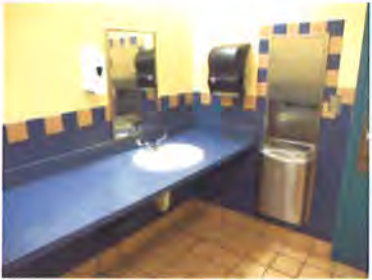
<b>ADA Standard Reference:</b>	<b>308.2, 603.4</b>

<b>Estimated Cost:</b>	<b>\$140.83</b>	
<b>Priority Level:</b>	<b>Low</b>	
<b>Barrier Description/Proposed Solution:</b>		
<p>The Men's restroom requires minor work items to be in compliance with ADA Standards. The existing coat hook has been torn off and requires replacement. The existing paper towel dispenser requires vertical adjustment. An estimate has been developed for the work items listed.</p>

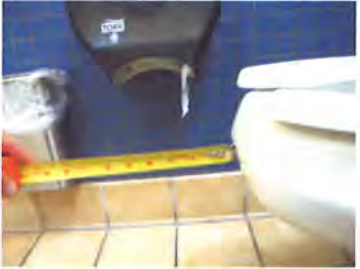
<b>Estimated Cost:</b>	<b>\$335.13</b>	
<b>Priority Level:</b>	<b>Low</b>	
<b>Barrier Description/Proposed Solution:</b>		
<p>The Women's restroom requires minor work items to be in compliance with ADA Standards. The soap dispenser, paper towel dispenser and toilet paper dispenser require mounting adjustment. (308.2.2, 308.2, 604.7). An estimate has been developed for the work items listed.</p>

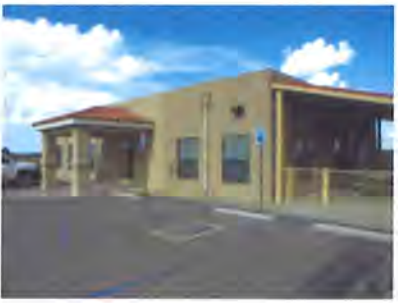
<b>ADA Standard Reference:</b>	<b>208.2.4, 502.6</b>

<b>Estimated Cost:</b>	<b>\$213.97</b>	
<b>Priority Level:</b>	<b>Low</b>	
<b>Barrier Description/Proposed Solution:</b> The existing parking lot provides for 2 accessible parking spaces. The spaces are large enough to be "van accessible"; however, existing signs do not designate as such. An estimate had been developed to remove 1 of the accessible parking signs and install a "van accessible" sign.

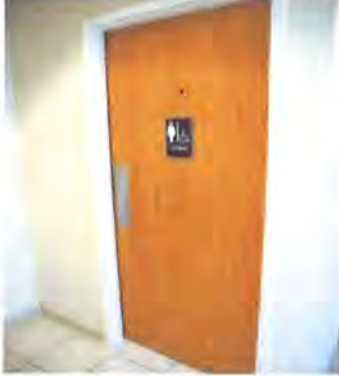
<b>ADA Standard Reference:</b>	<b>703.4.2, 306.3.3, 604.8.1.2</b>

<b>Estimated Cost:</b>	<b>\$701.40</b>	
<b>Priority Level:</b>	<b>Low</b>	
<b>Barrier Description/Proposed Solution:</b> Multiple work items in the existing Men's and Women's restroom are required for compliance with the referenced sections. The existing room signs require relocation to the latch side of the door (703.4.2). The accessible stall partition doors require adjustment to achieve self-closing (604.8.1.2). An estimate has been developed for the work items listed.

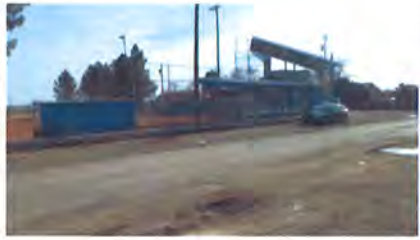
<b>ADA Standard Reference:</b>	206.2.1

<b>Estimated Cost:</b>	\$4,092.87	
<b>Priority Level:</b>	High	
<b>Barrier Description/Proposed Solution:</b> The existing ball park does not currently provide dedicated parking or handicap accessible spaces. An estimate has been developed for the installation of a new 24'x22' concrete pad with appropriate pavement markings, including handicap signs and wheel stops. New access aisles should be painted with blue paint and include text that indicates "NO PARKING". The estimate includes an Architectural and Engineering fee.

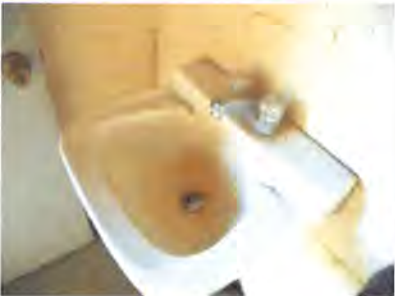
<b>ADA Standard Reference:</b>	<b>606.4</b>

<b>Estimated Cost:</b>	<b>\$1,100.52</b>	
<b>Priority Level:</b>	<b>Medium</b>	
<b>Barrier Description/Proposed Solution:</b> The existing restroom lavatories require the faucets be replaced with ADA compliant fixtures and the pipes be insulated to protect against contact. An estimate has been developed for the items listed.

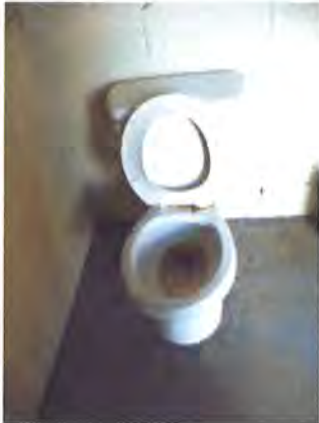
<b>Estimated Cost:</b>	<b>\$2,608.89</b>	
<b>Priority Level:</b>	<b>High</b>	
<b>Barrier Description/Proposed Solution:</b> The existing restrooms require several work items to be in compliance with the referenced sections. The existing toilet paper dispensers require adjustment to the required mounting height-(604.7). Sidewall and rear wall grabs bars require installation in both restrooms (604.5.1, 604.5.2). In the Women's restroom the water closet mounting location requires adjustment to the appropriate distance from the side wall (604.2). In the Men's restroom the existing urinal needs to be removed and the water closet relocated to side wall (609.4). An estimate has been developed for the work items listed.

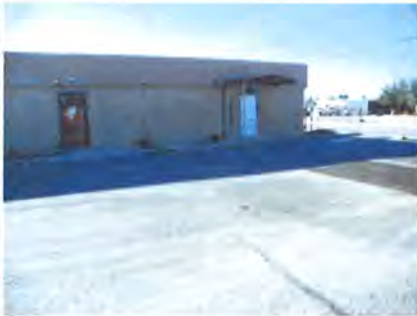
<b>Estimated Cost:</b>	<b>\$2,981.57</b>	
<b>Priority Level:</b>	<b>Medium</b>	
<b>Barrier Description/Proposed Solution:</b> The existing parking lot provides an accessible parking space and access aisle. However, the location of the parking is not at the nearest location to the entry and the access aisle does not adjoin to the accessible route. The accessible route is 1"-2" higher than the asphalt paving. It is recommended that the accessible spaces be relocated, so that the access aisle aligns with the entry and that a new concrete pad be installed so the parking is flush with the existing sidewalk. The access aisles should be painted with blue paint and include text that indicates "NO PARKING". An estimate has been developed for the work items listed.

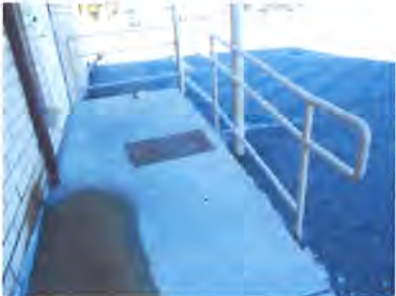
<b>ADA Standard Reference:</b>	<b>405.8, 405.9.1, 505.3, 505.10.1</b>

<b>Estimated Cost:</b>	<b>\$1,950.87</b>	
<b>Priority Level:</b>	<b>Low</b>	
<b>Barrier Description/Proposed Solution:</b>		
<p>The existing handrail does not comply with the requirements of the referenced sections. There is only railing on 1 side of the ramp and requires railing on both sides (405.8). The railing does not provide an unobstructed gripping surface (505.3). The rail does not extend at least 12" beyond the bottom of the ramp (505.10.1). Edge protection is not provided (405.9.1). An estimate has been developed for the removal and replacement of the railing.</p>

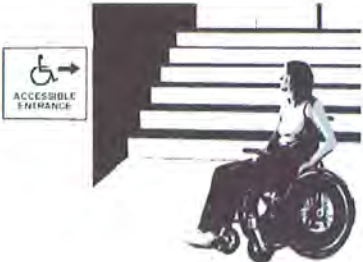
<b>ADA Standard Reference:</b>	<b>216.6</b>

<b>Estimated Cost:</b>	<b>\$284.61</b>	
<b>Priority Level:</b>	<b>Low</b>	
<b>Barrier Description/Proposed Solution:</b>		
<p>This facility has 3 entry doors; 1 of which is the Public accessible entry. Directional signs require installation at the inaccessible entries indicating the direction of the accessible entry. The sign at the accessible entry should have the International Symbol of Accessibility. An estimate has been developed for the installation of 3 new tactile text with Braille signs.</p>

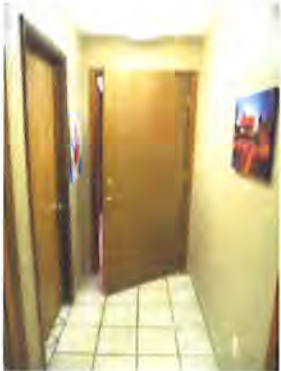
<b>ADA Standard Reference:</b>	<b>404.2.4</b>

<b>Estimated Cost:</b>	<b>\$125.51</b>	
<b>Priority Level:</b>	<b>Medium</b>	
<b>Barrier Description/Proposed Solution:</b>		
<p>The hallway has a security door that only provides 5" of maneuvering clearance on the latch side of the door. During business hours the door is held open. The nature of the building's use may require that the door remain, but that a sign be posted that it remain open during business hours. The permanent solution to this obstruction is to remove the door completely. An estimate has been developed for the removal of the door.</p>

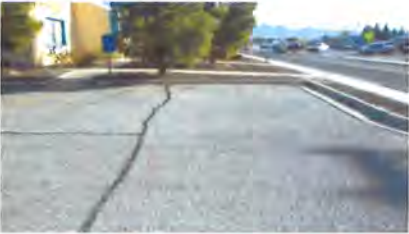
<b>ADA Standard Reference:</b>	208.2.4, 302.1, 406.1, 502.2, 502.6,

<b>Estimated Cost:</b>	\$3,053.60	
<b>Priority Level:</b>	Medium	
<b>Barrier Description/Proposed Solution:</b> The existing parking lot currently provides 16 total standard spaces with 1 accessible space. The existing pavement markings are faded and do not clearly indicate the spaces and access aisle. The ADA sign is not mounted at the appropriate height nor does it indicate the space as "van accessible" (502.2, 502.6). The slope and transition of the asphalt to the concrete curb ramp is uneven (302.1). The existing curb ramp exceeds the maximum slope (406.1). An estimate has been developed to remove and replace the existing asphalt with a new concrete pad. New pavement markings should account for an 8' space and 5' access aisle that with blue paint indicates "NO PARKING". New ADA signs should be put up and a new curb ramp installed.

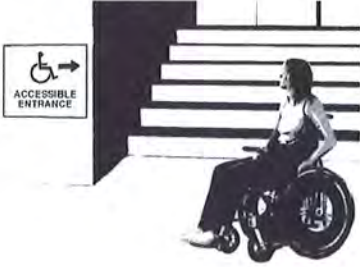
<b>ADA Standard Reference:</b>	216.6

<b>Estimated Cost:</b>	\$284.61	
<b>Priority Level:</b>	Low	
<b>Barrier Description/Proposed Solution:</b> Signs indicating the direction of the nearest ADA accessible entrance need to be installed on the Southwest corner of the building. A sign also needs to be installed at the South side accessible entrance with the International Symbol of Accessibility. An estimate has been developed for the installation of 3 new tactile text with Braille signs.

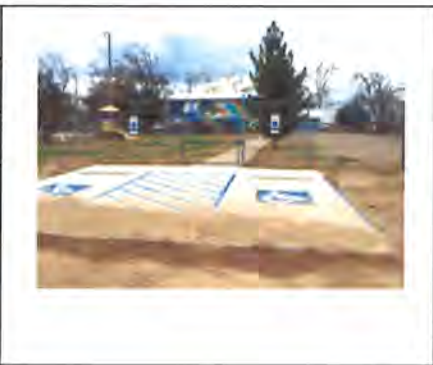
<b>ADA Standard Reference:</b>	<b>216.6</b>
<b>Estimated Cost:</b>	<b>\$59.28</b>
<b>Priority Level:</b>	<b>Low</b>
<b>Barrier Description/Proposed Solution:</b>	
<p>The existing inaccessible entrance does not have a sign indicating the location of the nearest accessible entrance. An estimate had been developed to install a directional sign at the inaccessible entrance.</p>

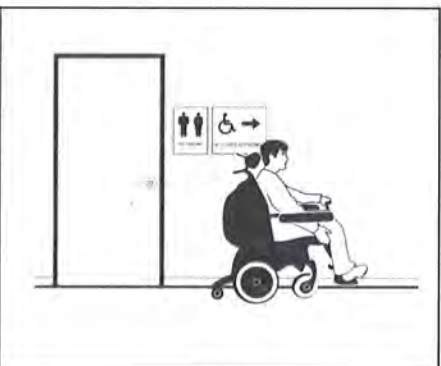
<b>ADA Standard Reference:</b>	<b>216.8, 703</b>
<b>Estimated Cost:</b>	<b>\$251.84</b>
<b>Priority Level:</b>	<b>Low</b>
<b>Barrier Description/Proposed Solution:</b>	
<p>This facility has 2 restrooms; 1 is accessible. A directional sign indicating the location of the accessible restroom should be installed at the inaccessible restroom. 2 room signs with tactile text and Braille require installation. An estimate has been developed for the work items listed.</p>

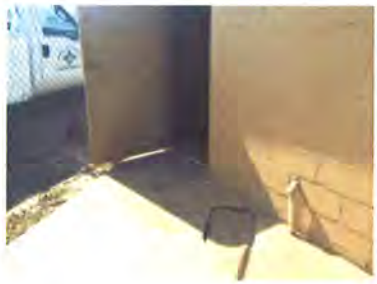
<b>ADA Standard Reference:</b>	<b>302.1</b>

<b>Estimated Cost:</b>	<b>\$151.98</b>	
<b>Priority Level:</b>	<b>Medium</b>	
<b>Barrier Description/Proposed Solution:</b>		
<p>The existing utility box cover outside the door of the restroom is not flush with the concrete. An estimate has been developed to remove and replace the utility box.</p>

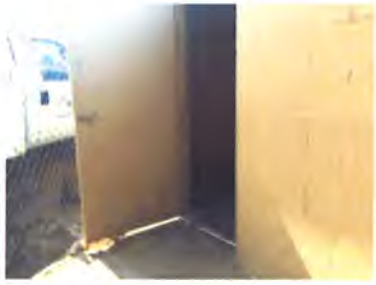
<b>ADA Standard Reference:</b>	<b>404.2.4</b>

<b>Estimated Cost:</b>	<b>\$1,174.48</b>	
<b>Priority Level:</b>	<b>Medium</b>	
<b>Barrier Description/Proposed Solution:</b>		
<p>The existing doors require removal and replacement with a new door assembly, including all required hardware. The door swings should be reversed to provide maneuvering clearances. An estimate has been developed for the items listed.</p>

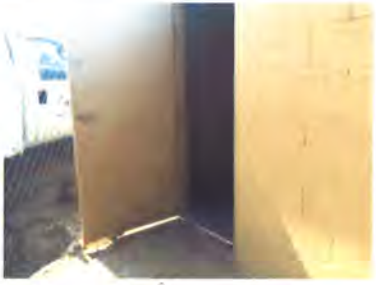
<b>ADA Standard Reference:</b>	<b>703</b>

<b>Estimated Cost:</b>	<b>\$227.14</b>	
<b>Priority Level:</b>	<b>Low</b>	
<b>Barrier Description/Proposed Solution:</b>		
<p>2 room signs are required at the existing restrooms. An estimate has been developed for the installation of 2 new tactile text with Braille signs.</p>

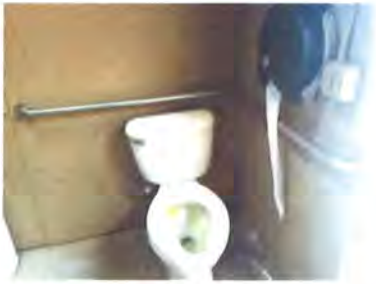
<b>ADA Standard Reference:</b>	<b>606.5, 606.4, 308.2.2, 308.2, 604.5.1, 604.5.2</b>

<b>Estimated Cost:</b>	<b>\$5,691.85</b>	
<b>Priority Level:</b>	<b>Medium</b>	
<b>Barrier Description/Proposed Solution:</b>		
<p>The 2 restrooms do not provide accessibility. An estimate had been developed for a complete reconfiguration of the restrooms. Work items to include an entire removal of all restroom fixtures and accessories. The installation of all new ADA compliant plumbing, fixtures, and accessories. An estimate has been developed for the work items listed.</p>

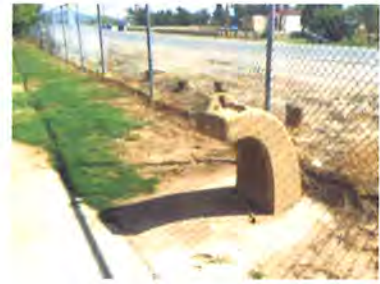
<b>ADA Standard Reference:</b>	<b>602.2, 602.5</b>
<b>Estimated Cost:</b>	<b>\$3,562.16</b>
<b>Priority Level:</b>	<b>Low</b>
<b>Barrier Description/Proposed Solution:</b>	
The existing drinking fountain does not meet ADA compliance. An estimate has been developed to remove and replace the drinking fountain.

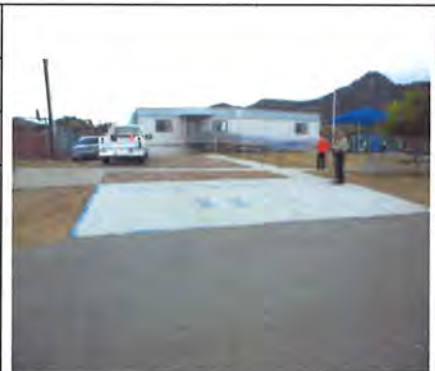
<b>ADA Standard Reference:</b>	<b>208.3.1</b>
<b>Estimated Cost:</b>	<b>\$3,107.69</b>
<b>Priority Level:</b>	<b>Medium</b>
<b>Barrier Description/Proposed Solution:</b>	
The existing accessible parking requires reconfiguration to comply with the requirements of the referenced sections. At the existing ADA parking space both pavement markings and sign require removal. There is also gravel parking at the base of the access ramp where a new (18' x 22') concrete pad should be placed with appropriate pavement markings and ADA sign. The access aisle should be painted with blue paint and include text that indicates "NO PARKING". An estimate has been developed for the items listed.
