# Doña Ana County

AMERICANS WITH DISABILITIES ACT  
SELF-EVALUATION  
AND  
TRANSITION PLAN  
DECEMBER 2017

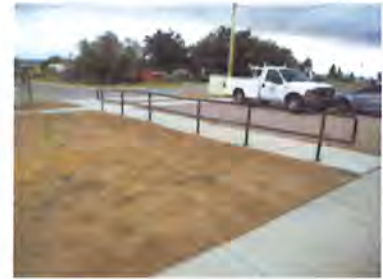
<b>ADA Standard Reference:</b>	<b>403.3</b>
<b>Estimated Cost:</b>	<b>\$1,090.05</b>
<b>Priority Level:</b>	<b>Medium</b>
<b>Barrier Description/Proposed Solution:</b>	
<p>The sidewalk to the access ramp is steep enough that it is classified as a ramp and needs to have handrails on both sides of the walk path. An estimate has been developed to install a handrail on the side of the ramp that does not have rails.</p>

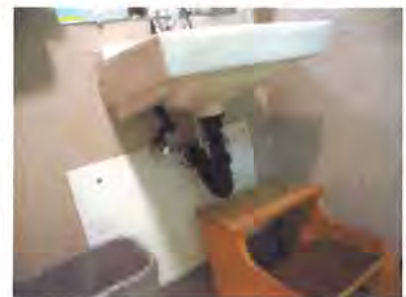
<b>ADA Standard Reference:</b>	<b>606.5, 606.4</b>
<b>Estimated Cost:</b>	<b>\$420.60</b>
<b>Priority Level:</b>	<b>Low</b>
<b>Barrier Description/Proposed Solution:</b>	
<p>The lavatories in both restrooms require that pipe insulation be installed to protect against contact. The faucets on both lavatories require hardware adjustment. An estimate has been developed for the work items listed.</p>

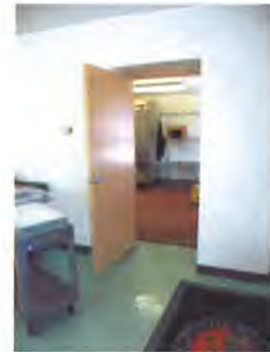
<b>ADA Standard Reference:</b>	<b>404.2.4</b>
<b>Estimated Cost:</b>	<b>\$82.16</b>
<b>Priority Level:</b>	<b>Low</b>
<b>Barrier Description/Proposed Solution:</b>	
The door to the kitchen is set flush with the kitchen wall limiting latch side clearances to the activity room. An estimate has been developed to move the door out of the alcove to be flush with the activity room wall.

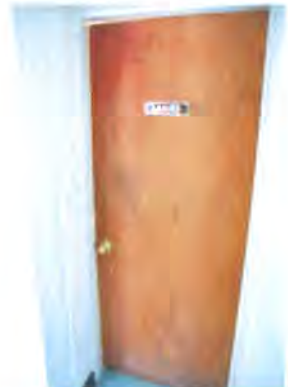
<b>ADA Standard Reference:</b>	<b>404.2.3, 404.2.4</b>
<b>Estimated Cost:</b>	<b>\$986.68</b>
<b>Priority Level:</b>	<b>High</b>
<b>Barrier Description/Proposed Solution:</b>	
The 2 existing restroom doors are too narrow for wheelchair access. An estimate has been developed to remove the existing doors and prepare the openings for the installation of a new 32" wide minimum opening. The new doors should be installed with the swings reversed to provide adequate pull-side clearances and should be installed with the appropriate ADA hardware. An estimate has been developed for the work items noted. The estimate also includes an Architectural/Engineering fee for the alteration of the openings.

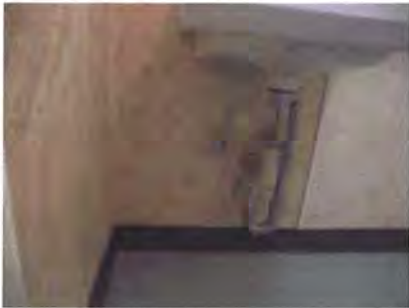
<b>ADA Standard Reference:</b>	<b>308.2, 308.2.2, 606.5</b>

<b>Estimated Cost:</b>	<b>\$287.02</b>	
<b>Priority Level:</b>	<b>Low</b>	
<b>Barrier Description/Proposed Solution:</b>		
<p>Several work items in the existing accessible restrooms are required for compliance with the referenced sections. The lavatories require that pipe insulation be installed to protect against contact (606.5). The soap dispenser in the Women's restroom requires mounting adjustment (308.2.2). The towel dispenser in the Men's restroom requires mounting adjustment (308.2). An estimate has been developed for the items listed.</p>

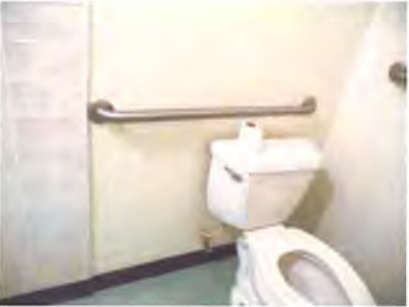
<b>ADA Standard Reference:</b>	<b>604.5.1, 604.5.2, 604.6</b>

<b>Estimated Cost:</b>	<b>\$667.87</b>	
<b>Priority Level:</b>	<b>Low</b>	
<b>Barrier Description/Proposed Solution:</b>		
<p>Several work items in the existing accessible restrooms are required for compliance with the referenced sections. The existing side wall and rear wall grab bars require horizontal adjustment (604.5.1, 604.5.2). The flush control on the Men's water closet requires relocation to the open side of the unit (604.6). An estimate has been developed for the work items listed.</p>

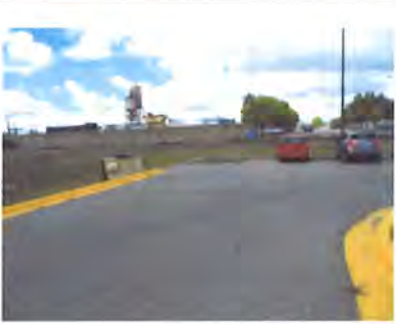
<b>ADA Standard Reference:</b>	<b>502.2.2, 502.3</b>

<b>Estimated Cost:</b>	<b>\$3,615.94</b>	
<b>Priority Level:</b>	<b>Medium</b>	
<b>Barrier Description/Proposed Solution:</b> The existing accessible parking requires reconfiguration to comply with the requirements of the referenced sections. Work items to include: construction of a new sidewalk with curb ramp, appropriate pavement markings, and new signs. The access aisle should be painted with blue paint and include text that indicates "NO PARKING".

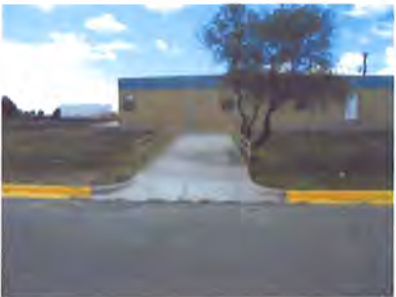
<b>ADA Standard Reference:</b>	<b>505.10.1</b>

<b>Estimated Cost:</b>	<b>\$280.34</b>	
<b>Priority Level:</b>	<b>Low</b>	
<b>Barrier Description/Proposed Solution:</b> The existing railing at the accessible walking ramp requires retrofit to the base of the rail that provides a barrier that prevents the passage of a 4" diameter sphere. An estimate has been developed for the item noted.

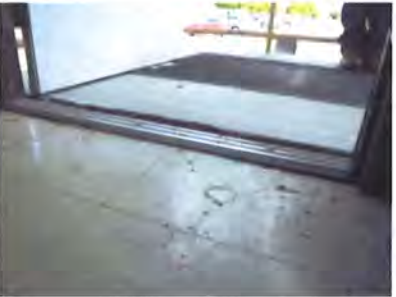
<b>ADA Standard Reference:</b>	<b>404.2.5, 303.2</b>

<b>Estimated Cost:</b>	<b>\$234.51</b>	
<b>Priority Level:</b>	<b>Low</b>	
<b>Barrier Description/Proposed Solution:</b> The existing ramp at the entry is higher than the metal threshold at the entrance door. An estimate has been developed to install a threshold ramp.

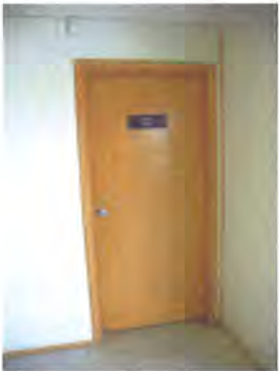
<b>ADA Standard Reference:</b>	<b>216.8, 703.5, 703.2, 703.3, 703.4.2, 703.4.1</b>

<b>Estimated Cost:</b>	<b>\$171.22</b>	
<b>Priority Level:</b>	<b>Low</b>	
<b>Barrier Description/Proposed Solution:</b> This facility has 3 restrooms; 2 which are accessible. A directional sign indicating the location of the accessible restrooms should be installed at the Employee restroom. 2 tactile signs need to be installed at the accessible restrooms indicating the Sign of International Accessibility. An estimate has been developed for installation of 3 new tactile text with Braille signs.

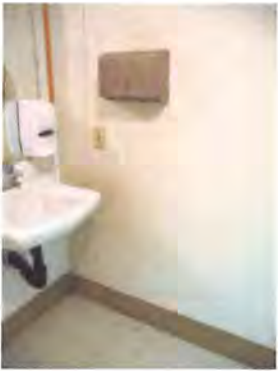
<b>ADA Standard Reference:</b>	<b>308.2, 604.5.2, 606.5</b>

<b>Estimated Cost:</b>	<b>\$251.29</b>	
<b>Priority Level:</b>	<b>Low</b>	
<b>Barrier Description/Proposed Solution:</b>		
<p>Several work items in the existing Men's accessible restroom are required for compliance with the referenced sections. Pipe insulation requires installation to protect against contact (606.5). The paper towel dispenser requires vertical adjustment (308.2). The rear grab bar requires horizontal adjustment (604.5.2). An estimate has been developed for the work items listed.</p>

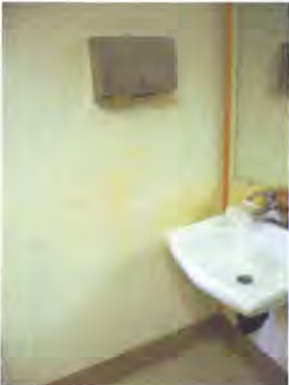
<b>ADA Standard Reference:</b>	<b>308.2, 604.5.2, 604.6, 606.5</b>

<b>Estimated Cost:</b>	<b>\$486.24</b>	
<b>Priority Level:</b>	<b>Low</b>	
<b>Barrier Description/Proposed Solution:</b>		
<p>Several work items in the existing Women's accessible restroom are required for compliance with the referenced sections. Pipe insulation requires installation to protect against contact (606.5). The paper towel dispenser requires vertical adjustment (308.2). The rear grab bar requires horizontal adjustment (604.5.2). The flush control on the water closet requires relocation to the open side of the unit (604.6). An estimate has been developed for the work items listed.</p>

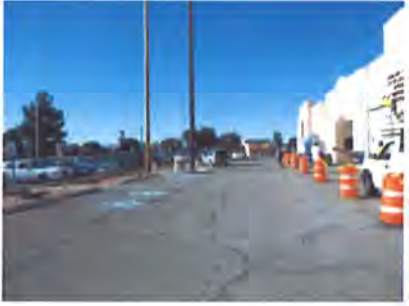
<b>ADA Standard Reference:</b>	302.1, 502.2, 503.3

<b>Estimated Cost:</b>	\$10,624.81	
<b>Priority Level:</b>	Low	
<b>Barrier Description/Proposed Solution:</b>		
<p>The existing accessible parking requires reconfiguration to comply with the requirements of the referenced sections. Work items to include: removal and replacement of the existing heaving asphalt and re-stripping pavement markings. The access aisles should be painted with blue paint and include text that indicates "NO PARKING".</p>

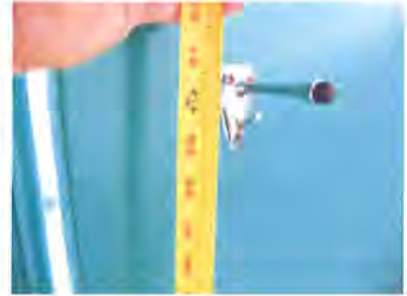
<b>ADA Standard Reference:</b>	<b>308.2, 603.4, 604.2, 604.5.1, 604.5.2, 604.7, 606.5</b>
<b>Estimated Cost:</b>	<b>\$731.82</b>
<b>Priority Level:</b>	<b>Low</b>
<b>Barrier Description/Proposed Solution:</b>	
Several work items in the Men's South Lobby restroom are required for compliance with the referenced sections. The existing coat hook is broken or at the wrong height and a new hook should be installed (603.4).The lavatories require pipe insulation to protect against contact (606.5). The water closet, paper towel dispenser, rear and side grab bars, and toilet paper dispenser require mounting adjustment (604.2, 308.2, 604.5.1, 604.5.2, 604.7).

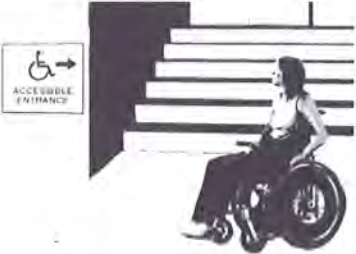
<b>ADA Standard Reference:</b>	<b>216.6</b>

<b>Estimated Cost:</b>	<b>\$59.28</b>	
<b>Priority Level:</b>	<b>Low</b>	
<b>Barrier Description/Proposed Solution:</b>		
<p>The existing inaccessible entrance does not have a sign that indicates the location of the nearest accessible entrance. An estimate has been developed to install a directional sign.</p>

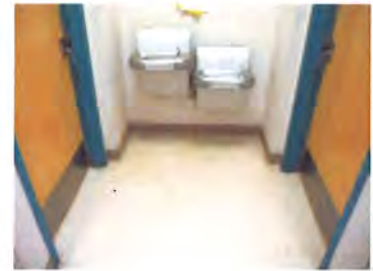
<b>ADA Standard Reference:</b>	<b>602.7</b>
<b>Estimated Cost:</b>	<b>\$262.19</b>
<b>Priority Level:</b>	<b>Low</b>
<b>Barrier Description/Proposed Solution:</b>	
1 of the existing drinking fountains is below the minimum mounting height required. An estimate has been developed to adjust the mounting of the drinking fountain to meet ADA compliance.

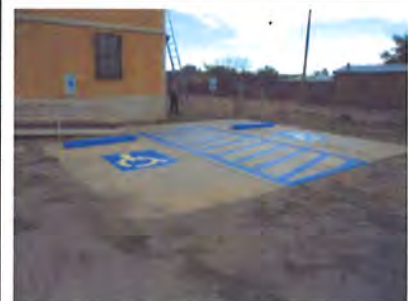
<b>ADA Standard Reference:</b>	<b>502.6</b>
<b>Estimated Cost:</b>	<b>\$270.16</b>
<b>Priority Level:</b>	<b>Low</b>
<b>Barrier Description/Proposed Solution:</b>	
The existing ADA parking signs are too low. An estimate has been developed to raise 2 signs to 60" AFF minimum.

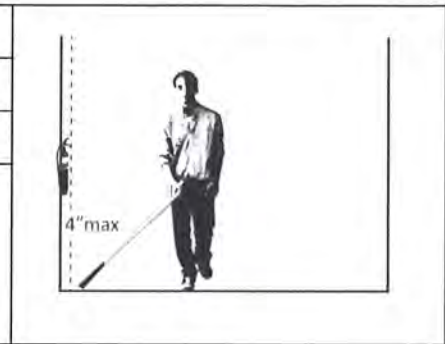
<b>ADA Standard Reference:</b>	<b>307.2</b>
<b>Estimated Cost:</b>	<b>\$318.27</b>
<b>Priority Level:</b>	<b>Low</b>
<b>Barrier Description/Proposed Solution:</b>	
The fire extinguisher protrudes 6" into the walking path and 48" AFF. An estimate has been developed for the installation of a fire extinguisher cabinet.

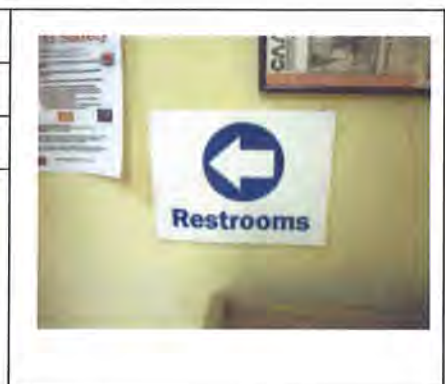
<b>ADA Standard Reference:</b>	<b>216.8, 703</b>
<b>Estimated Cost:</b>	<b>\$171.22</b>
<b>Priority Level:</b>	<b>Low</b>
<b>Barrier Description/Proposed Solution:</b>	
This facility has 2 restrooms; 1 is accessible. A directional sign indicating the location of the nearest accessible restroom should be installed at the inaccessible restroom. 2 new room signs with tactile text and Braille should be installed. An estimate has been developed for the work item noted.

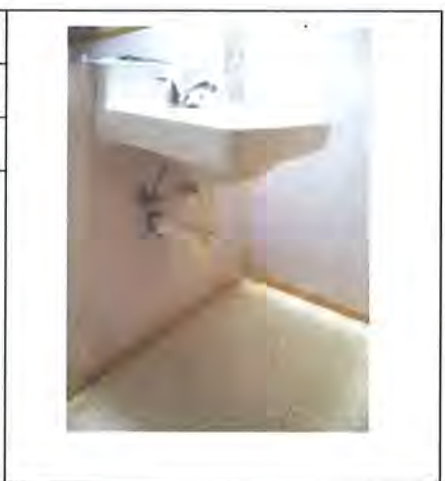
<b>ADA Standard Reference:</b>	<b>603.3, 604.5.1, 604.5.2, 604.6, 606.5</b>
<b>Estimated Cost:</b>	<b>\$594.92</b>
<b>Priority Level:</b>	<b>Low</b>
<b>Barrier Description/Proposed Solution:</b>	
Several work items in the existing Men's restroom are required for compliance with the referenced sections. The existing mirror requires adjustment to the appropriate mounting height (603.3). The lavatory requires the installation of pipe insulation to protect against contact (606.5). The existing side wall and rear wall grab bars require horizontal adjustment (604.5.1, 604.5.2). The flush control on the water closet requires relocation to the open side of the unit (604.6). An estimate has been developed for the work items listed.

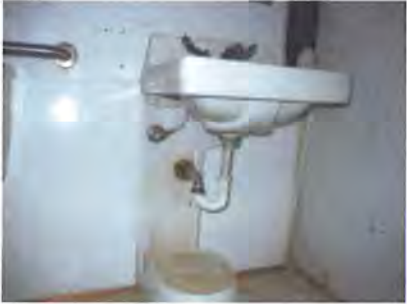
<b>ADA Standard Reference:</b>	<b>604.5.1, 604.5.2, 604.6, 606.5</b>

<b>Estimated Cost:</b>	<b>\$486.69</b>	
<b>Priority Level:</b>	<b>Low</b>	
<b>Barrier Description/Proposed Solution:</b>		
<p>Several work items in the existing Women's restroom are required for compliance with the referenced sections. The lavatory requires the installation of pipe insulation to protect against contact (606.5). The existing side wall and rear wall grab bars require horizontal adjustment (604.5.1, 604.5.2). The flush control on the water closet requires relocation to the open side of the unit (604.6). An estimate has been developed for the work items listed.</p>

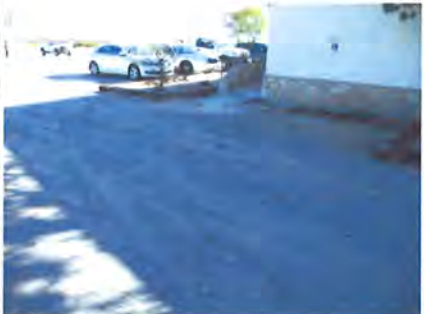
<b>ADA Standard Reference:</b>	<b>208.2, 405.7.3, 502.6</b>

<b>Estimated Cost:</b>	<b>\$2,642.71</b>	
<b>Priority Level:</b>	<b>High</b>	
<b>Barrier Description/Proposed Solution:</b>		
<p>The existing gravel parking lot does not provide an accessible space and access aisle that complies with the requirements of the referenced sections. An estimate has been developed for the installation of a new 18'x20' concrete pad with the appropriate pavement markings, wheel stop, and new ADA sign. The access aisle should be aligned with the accessible route. Access aisles should be painted with blue paint and include text that indicates "NO PARKING". The existing ramp has a 48" extension of concrete that should be removed for the installation of the new concrete pad.</p>

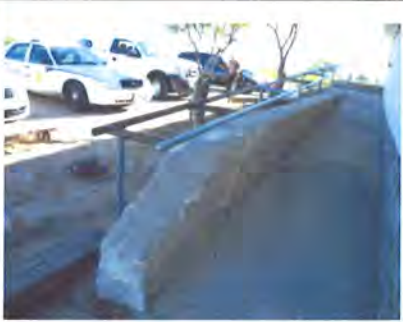
<b>ADA Standard Reference:</b>	<b>405.8</b>

<b>Estimated Cost:</b>	<b>\$1,512.00</b>	
<b>Priority Level:</b>	<b>Medium</b>	
<b>Barrier Description/Proposed Solution:</b> The existing ramp includes a handrail that is noncompliant. It is recommended that the existing handrail be removed and a new handrail be installed on each side of the ramp. An estimate has been developed for the installation of 70 L.F. of railing.

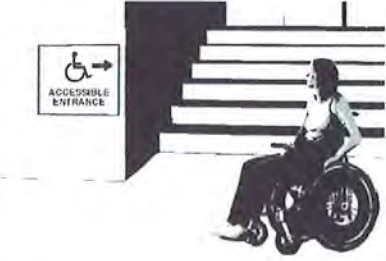
<b>ADA Standard Reference:</b>	<b>216.6</b>

<b>Estimated Cost:</b>	<b>\$86.80</b>	
<b>Priority Level:</b>	<b>Low</b>	
<b>Barrier Description/Proposed Solution:</b> This facility has 2 entrances. A directional sign needs to be installed indicating the direction of the main accessible entrance and a sign needs to be installed at the accessible entrance indicating ADA accessibility. An estimate has been developed for the installation of the signs.

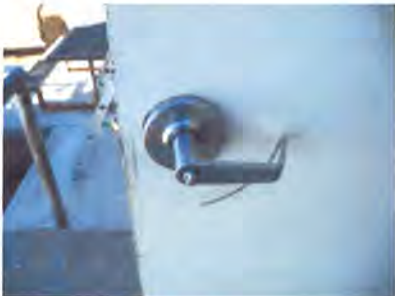
<b>ADA Standard Reference:</b>	<b>404.2.4, 404.2.7</b>

<b>Estimated Cost:</b>	<b>\$973.66</b>	
<b>Priority Level:</b>	<b>Medium</b>	
<b>Barrier Description/Proposed Solution:</b> The existing entry door does not have adequate maneuvering clearance beyond the latch side of the door. The existing lockset on the door requires a grasping, pinching, and twisting motion to lock and should be replaced with push/pull plate hardware and deadbolt.

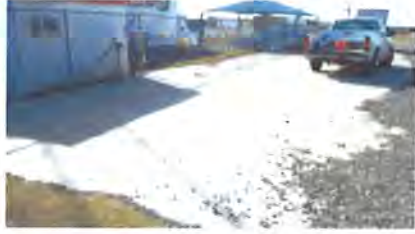
<b>ADA Standard Reference:</b>	<b>208.2.4,502.2,502.3, 502.3.3, 502.6</b>

<b>Estimated Cost:</b>	<b>\$3,796.06</b>	
<b>Priority Level:</b>	<b>Low</b>	
<b>Barrier Description/Proposed Solution:</b> The existing parking lot does not have any designated pavement markings. An estimate has been developed to paint 4 accessible parking spaces with 2 access aisles. Access aisles should be painted with blue paint and include text that indicates "NO PARKING". The estimate also includes the installation of 4 new signs; 1 of which should be designated as "van accessible".

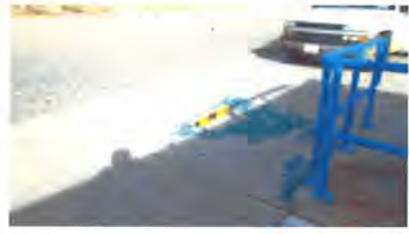
<b>ADA Standard Reference:</b>	<b>403.3</b>

<b>Estimated Cost:</b>	<b>\$1,456.56</b>	
<b>Priority Level:</b>	<b>Medium</b>	
<b>Barrier Description/Proposed Solution:</b> There are 3 sloped sidewalk areas at the speedway entry that exceed the maximum slope of 1:20. An estimate has been developed to remove and replace 200 S.F. of sidewalk to meet ADA compliance.

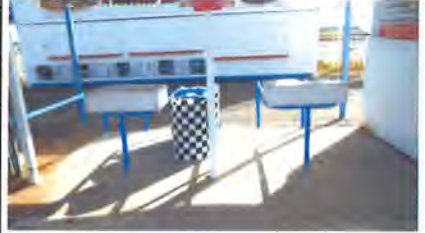
<b>ADA Standard Reference:</b>	<b>216.6</b>

<b>Estimated Cost:</b>	<b>\$703.87</b>	
<b>Priority Level:</b>	<b>High</b>	
<b>Barrier Description/Proposed Solution:</b> The main entrance to the speedway is not accessible. An estimate has been developed to remove a portion of the existing chain link fence and add a gate for a dedicated accessible entrance. Signs should be installed directing to and identifying the accessible entrance.

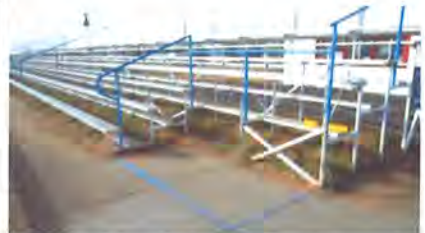
<b>ADA Standard Reference:</b>	<b>221.2.1</b>

<b>Estimated Cost:</b>	<b>\$875.88</b>	
<b>Priority Level:</b>	<b>High</b>	
<b>Barrier Description/Proposed Solution:</b> The existing Grandstands at the Speedway provide an estimated 4,451 standard seats and 2 wheelchair spaces. In Section 221.2.1 of the 2010 ADA Standards for Accessible Design requires that for every 500 standard seats provided, 6 wheelchair spaces are required. The code also requires that standard spaces between 501-5,000 require 1 wheelchair space for every 150 spaces. 30 wheelchair spaces are required; it is recommended that for each section of Grandstand the spaces are provided evenly. An estimate has been developed for the removal of 36 standard fixed seats to provide space for the required wheelchair spaces.

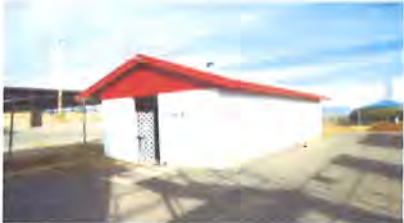
<b>ADA Standard Reference:</b>	<b>216.8</b>

<b>Estimated Cost:</b>	<b>\$135.84</b>	
<b>Priority Level:</b>	<b>Low</b>	
<b>Barrier Description/Proposed Solution:</b> The East Men's and Women's restroom require the installation of tactile text with Braille signs. An estimate has been developed for the item noted.

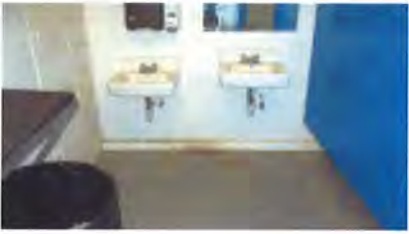
<b>ADA Standard Reference:</b>	<b>606.5, 606.4</b>

<b>Estimated Cost:</b>	<b>1,652.13</b>	
<b>Priority Level:</b>	<b>Medium</b>	
<b>Barrier Description/Proposed Solution:</b> The Men's and Women's lavatories require that pipe insulation and ADA faucets be installed. An estimate has been developed for the work items listed.

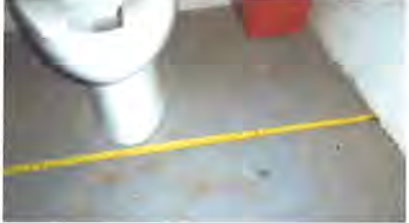
<b>ADA Standard Reference:</b>	<b>604.2, 604.5.1, 604.5.2, 609.3, 609.4</b>

<b>Estimated Cost:</b>	<b>\$791.94</b>	
<b>Priority Level:</b>	<b>Low</b>	
<b>Barrier Description/Proposed Solution:</b> Several work items in the Men's and Women's accessible stalls are required for compliance with the referenced sections. The existing water closet requires mounting location adjustment and replacement (604.2, 604.4). The existing sidewall grab bars require mounting adjustment (604.5.1). A 36" bar requires installation at the rear wall (604.5.2). The existing accessible stall toilet partition doors require complete removal and replacement to the required 32" door (604.8.1.2). An estimate has been developed for the work items listed.

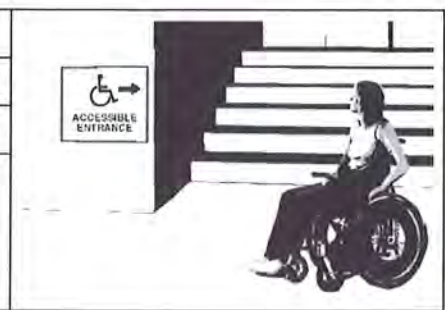
<b>ADA Standard Reference:</b>	<b>216.6</b>
<b>Estimated Cost:</b>	<b>\$94.87</b>
<b>Priority Level:</b>	<b>Low</b>
<b>Barrier Description/Proposed Solution:</b> The existing inaccessible entrance does not have a sign indicating the direction and location of the nearest accessible entrance. An estimate has been developed to install a new sign.

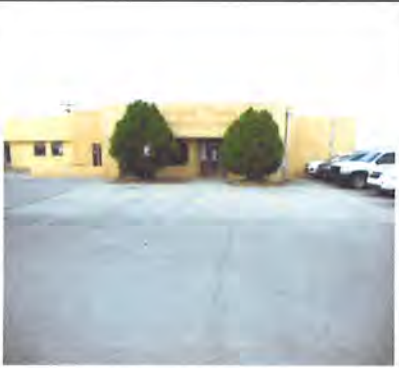
<b>ADA Standard Reference:</b>	<b>502.2, 502.3, 502.6</b>

<b>Estimated Cost:</b>	<b>\$2,634.06</b>	
<b>Priority Level:</b>	<b>Low</b>	
<b>Barrier Description/Proposed Solution:</b> The existing configuration of the accessible parking does not comply with the requirements of this section. The existing lines are faded and do not clearly designate parking and access aisles (502.2, 502.3). The existing ADA signs are faded and hard to read (502.6). An estimate has been developed for the reconfiguration of the parking to provide two 8' accessible spaces and an 8' access aisle in the middle. Access aisles should be painted with blue paint and include text that indicates "NO PARKING". New signs also require installation.

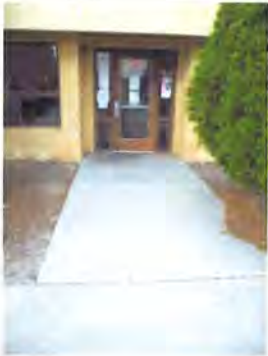
<b>ADA Standard Reference:</b>	<b>216.6</b>

<b>Estimated Cost:</b>	<b>\$284.61</b>	
<b>Priority Level:</b>	<b>Low</b>	
<b>Barrier Description/Proposed Solution:</b> Directional signs are not provided at inaccessible entries indicating the location of the nearest accessible entry. An estimate has been developed for the installation of 3 ADA compliant directional signs.

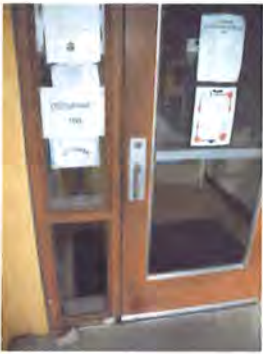
<b>ADA Standard Reference:</b>	<b>404.2.7, 404.2.8</b>

<b>Estimated Cost:</b>	<b>\$295.01</b>	
<b>Priority Level:</b>	<b>Medium</b>	
<b>Barrier Description/Proposed Solution:</b> The existing entry door has multiple issues that make it noncompliant. The lockset has a thumb trigger and the door closes in less than 5 seconds. An estimate has been developed to replace the lockset with a lever type system and adjust the door closer.

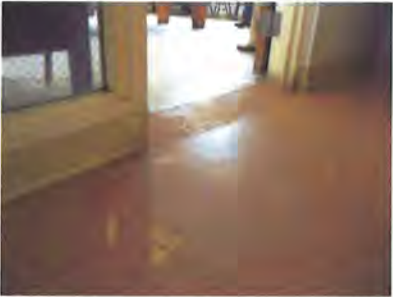
<b>ADA Standard Reference:</b>	<b>404.2.4</b>

<b>Estimated Cost:</b>	<b>\$83.33</b>	
<b>Priority Level:</b>	<b>Low</b>	
<b>Barrier Description/Proposed Solution:</b> There is a 1" transition between the Cafeteria and the Game room. This transition is minimal; however, it must be no greater than 1:48. An estimate has been developed for the beveling of the concrete to achieve the maximum slope allowed by this section.

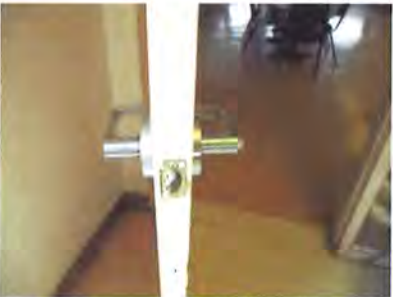
<b>ADA Standard Reference:</b>	<b>404.2.7, 404.2.8.1, 404.2.9</b>

<b>Estimated Cost:</b>	<b>\$295.01</b>	
<b>Priority Level:</b>	<b>Low</b>	
<b>Barrier Description/Proposed Solution:</b> The existing door to the lunch room requires that the lockset be replaced as the locking mechanism requires a pinch/push action to operate. The door takes a considerable amount of effort to open (than 5lbs of force) and closes in less than 5seconds. An estimate has been developed to replace the lockset and adjust the door closer.

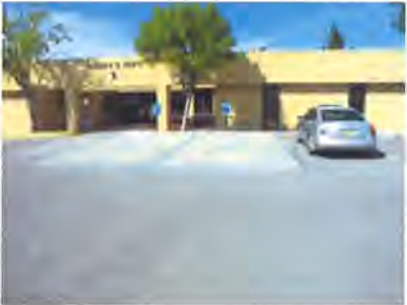
<b>ADA Standard Reference:</b>	<b>208.2.4, 502.2, 502.3, 502.3.3, 502.6</b>

<b>Estimated Cost:</b>	<b>\$3,602.31</b>	
<b>Priority Level:</b>	<b>Medium</b>	
<b>Barrier Description/Proposed Solution:</b> The existing accessible parking requires reconfiguration to comply with the requirements of the referenced sections. The accessible parking does not provide an access aisle (502.2, 502.3). The existing ADA signs do not designate "van accessibility" and are not mounted at the appropriate height (502.6). An estimate has been developed for the reconfiguration of the parking lot to allow for two 8' accessible spaces with an 8' access aisle in the middle. Wheel stops should be installed 5' from the existing curb to provide for an accessible route from the parking area to the main entrance. Access aisles should be painted with blue paint and include text that indicates "NO PARKING".

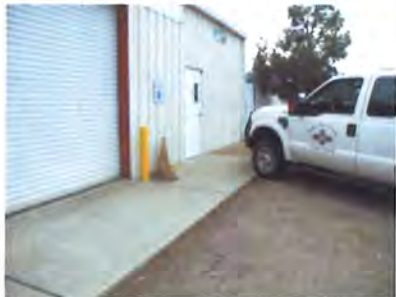
<b>ADA Standard Reference:</b>	502.2, 502.3

<b>Estimated Cost:</b>	\$2,677.84	
<b>Priority Level:</b>	Low	
<b>Barrier Description/Proposed Solution:</b> <p>The existing accessible parking requires reconfiguration to comply with the requirements of the referenced sections. Work items to include: construction of a new concrete pad (16' x 22'), striping, and the removal and replacement of the existing ADA sign with a new ADA 'Van Accessible' sign. The access aisle should be painted with blue paint and include text that indicates "NO PARKING".</p>

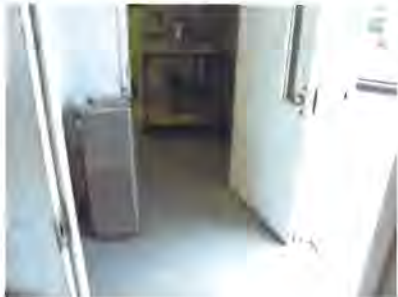
<b>ADA Standard Reference:</b>	<b>602.2</b>

<b>Estimated Cost:</b>	<b>\$1,926.91</b>	
<b>Priority Level:</b>	<b>Low</b>	
<b>Barrier Description/Proposed Solution:</b>		
<p>The existing drinking fountain located in the hall is noncompliant. An estimated has been developed to remove and replace the drinking fountain.</p>

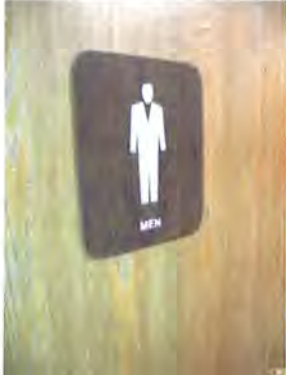
<b>ADA Standard Reference:</b>	<b>703</b>

<b>Estimated Cost:</b>	<b>\$141.18</b>	
<b>Priority Level:</b>	<b>Low</b>	
<b>Barrier Description/Proposed Solution:</b> The existing room signs at the restrooms are noncompliant. Only 1 restroom is large enough to be fully compliant. It is recommended that the larger restroom be designated as a unisex restroom and a new sign that indicates handicap accessibility be installed. An estimate has been developed for the installation of 2 new signs with tactile text and Braille.

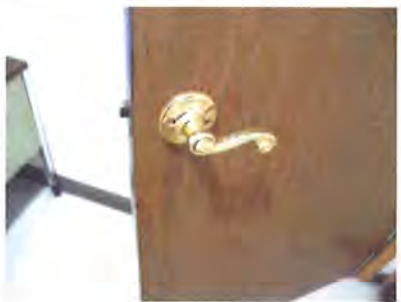
<b>ADA Standard Reference:</b>	<b>404.2.7</b>

<b>Estimated Cost:</b>	<b>\$373.32</b>	
<b>Priority Level:</b>	<b>Low</b>	
<b>Barrier Description/Proposed Solution:</b> The existing locksets on both restroom doors have a lock that requires a pinching and twisting motion to operate. An estimate has been developed for the replacement of the locksets.

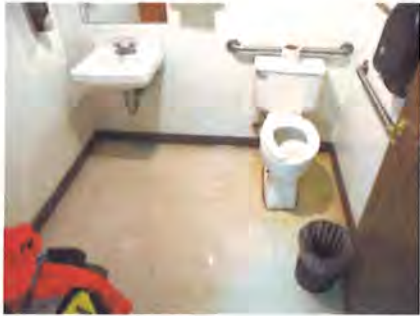
<b>ADA Standard Reference:</b>	<b>308.2, 604.2, 604.5.1, 604.6, 604.7</b>

<b>Estimated Cost:</b>	<b>\$813.31</b>	
<b>Priority Level:</b>	<b>Low</b>	
<b>Barrier Description/Proposed Solution:</b> The existing East restroom requires minor work items to be in compliance with the requirements of the referenced sections. The paper towel dispenser requires mounting height adjustment (308.2). The water closet requires mounting adjustment to provide the required distance from the side wall (604.2). The flush control requires relocation to the open side of the unit (604.6). The side wall grab bar requires horizontal mounting adjustment (604.5.1). The toilet paper dispenser requires mounting height adjustment (604.7). An estimate has been developed for the work items listed.

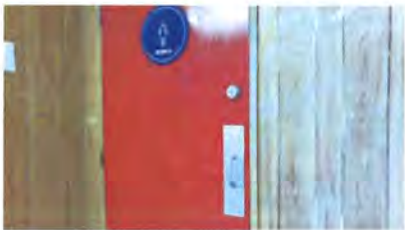
<b>ADA Standard Reference:</b>	<b>703.2, 703.3, 703.4.2, 216.8</b>

<b>Estimated Cost:</b>	<b>\$271.68</b>	
<b>Priority Level:</b>	<b>Low</b>	
<b>Barrier Description/Proposed Solution:</b> The Men's and Women's restrooms require the installation of new tactile text with Braille signs. An estimate has been developed to install 4 new signs.

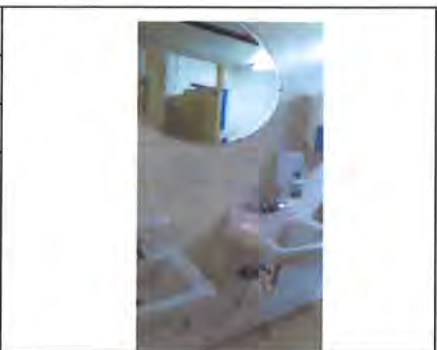
<b>ADA Standard Reference:</b>	<b>603.3, 604.4</b>
<b>Estimated Cost:</b>	<b>\$274.70</b>
<b>Priority Level:</b>	<b>Low</b>
<b>Barrier Description/Proposed Solution:</b> The mirrors in the Men's and Women's restroom require mounting adjustment. New coat hooks are required at the accessible stalls. An estimate has been developed for the items listed.

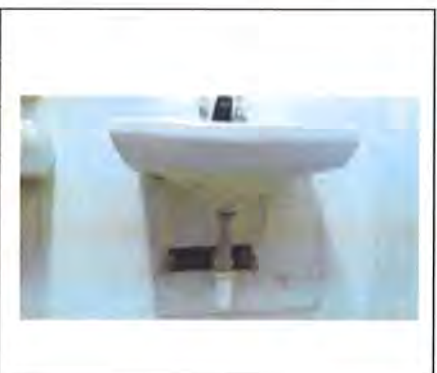
<b>ADA Standard Reference:</b>	<b>606.5, 606.4</b>
<b>Estimated Cost:</b>	<b>\$2,202.84</b>
<b>Priority Level:</b>	<b>Low</b>
<b>Barrier Description/Proposed Solution:</b> 2 lavatories in the Men's and 2 lavatories in the Women's restrooms do not have pipe insulation. They also have knob type faucet hardware. An estimate has been developed to install pipe insulation to the pipes and to remove and replace the faucets with lever type hardware.

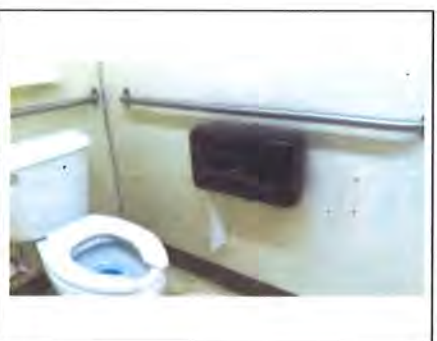
<b>ADA Standard Reference:</b>	<b>604.4</b>
<b>Estimated Cost:</b>	<b>\$1,012.78</b>
<b>Priority Level:</b>	<b>Medium</b>
<b>Barrier Description/Proposed Solution:</b> The water closets in the Men's and Women's accessible stalls are noncompliant and require replacement. An estimate has been developed for the item noted.

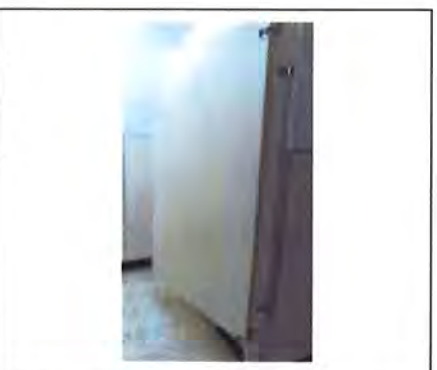
<b>ADA Standard Reference:</b>	<b>604.8.1.2</b>
<b>Estimated Cost:</b>	<b>\$215.62</b>
<b>Priority Level:</b>	<b>Low</b>
<b>Barrier Description/Proposed Solution:</b> The Men's and Women's accessible stall toilet partitions require mounting adjustment and doors are not self-closing. An estimate has been developed for the items listed.
